Subject: RAMPP West Virginia LiDAR QA/QC: Tug Watershed Delivery

RAMPP has been tasked and funded by FEMA Region III to perform LiDAR quality assurance and quality control checks for a 3,165km² portion of southern West Virginia. The evaluation will assess the usability of the LiDAR data in supporting the West Virginia Department of Environmental Protection Division of Mining and Reclamation. In addition, the report will comment on the LiDAR's adherence to FEMA's "Procedure Memorandum No. 61 – Standards for LiDAR and Other High Quality Digital Topography." The delivery includes 1,368 LAS tiles. The dataset is referred to as the Tug Watershed delivery.

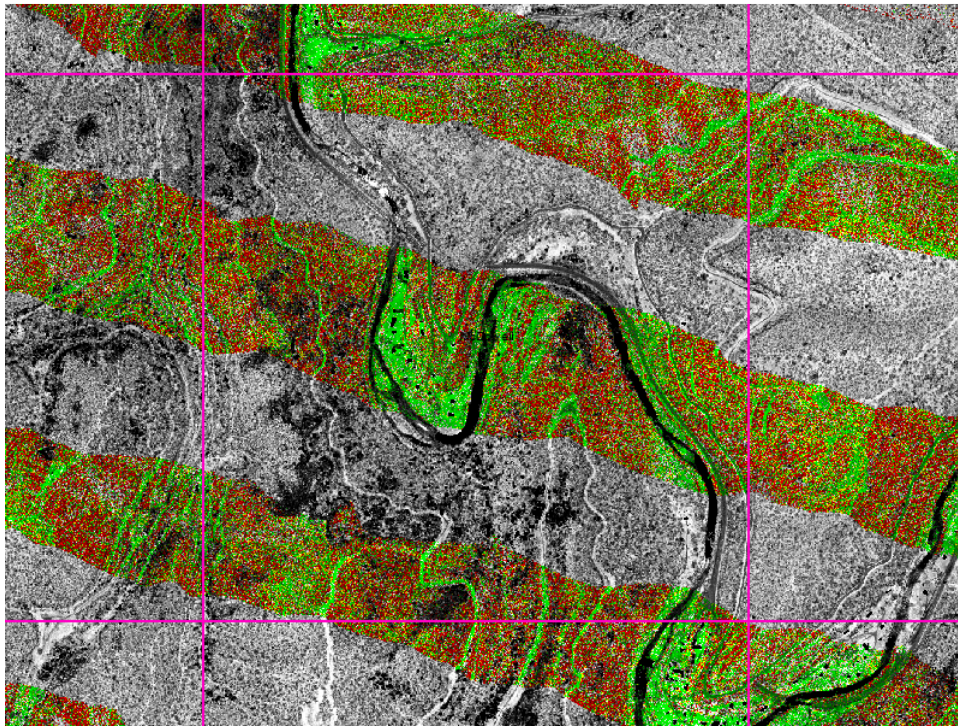
Figure 2 - Delta-Z ortho image of tile C027661

In the image above, the pixel size was 2 meters and the error gradient was 0.15 meters, meaning the green pixels have an error value of less than 0.15 meters, the yellow pixels have an error of 0.15-0.30 meters, and the red pixels have an error of greater than 0.30 meters. Due to the extremely high relief in the project area many of the pixels showing large elevation errors are not reliable. In this situation a higher priority was placed on the low-relief areas, such as the areas around the river and along the roads. The image above is a good example of the quality of the Tug Watershed dataset, where a low delta-Z error is prevalent in the low-relief areas around the river and along the roads.

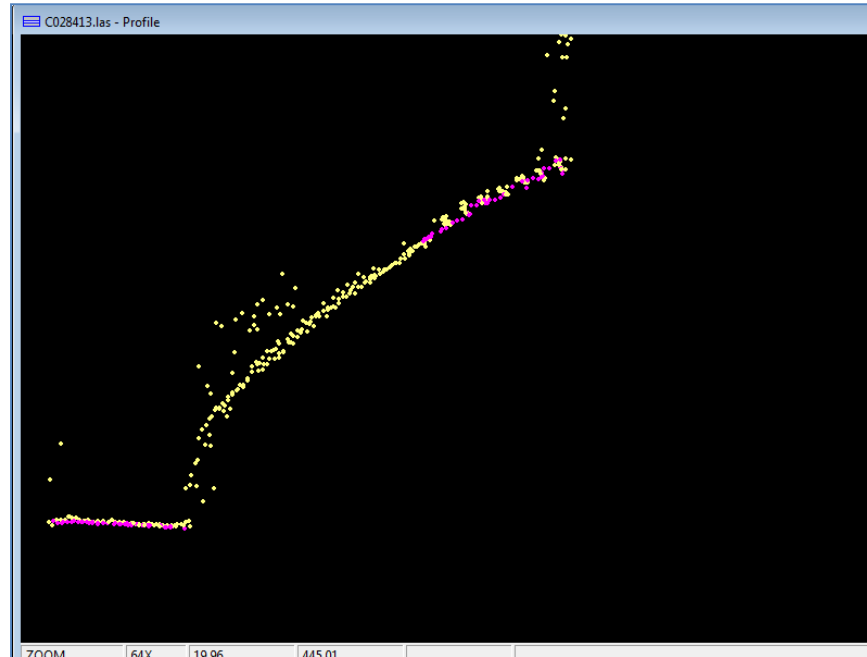
relies on point-to-point distance and angle to determine if a point is ground or non-ground, ground points at the apex of a hill or ridge can be “aggressively” classified out of the ground. Figure 4 below shows ground points in tile C028413 that have been aggressively classified.

Figure 4: Aggressive Classification in tile C028413. The purple points are ground and yellow are non-ground.

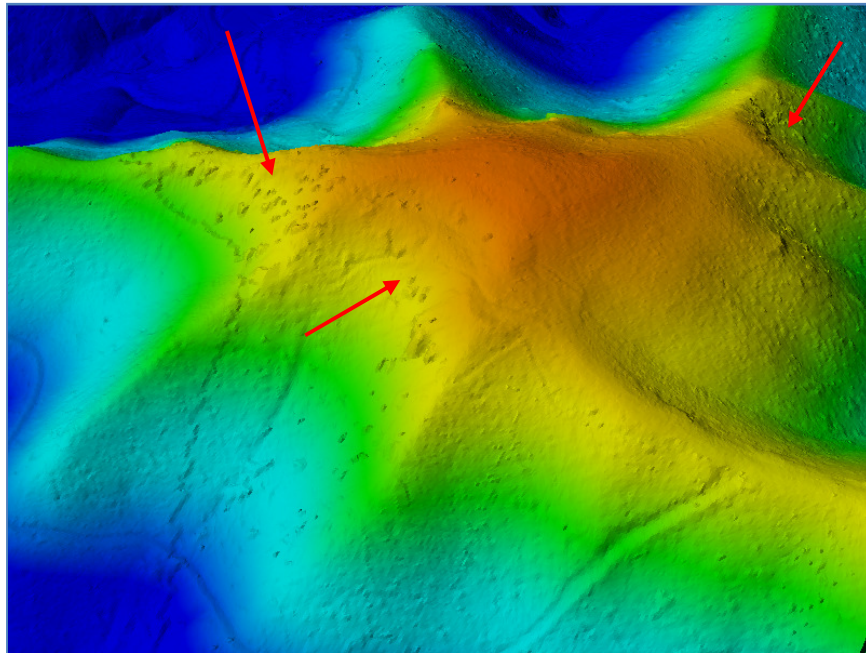
Figure 5: Tile C022986 showing vegetation artifacts along the side of the hill

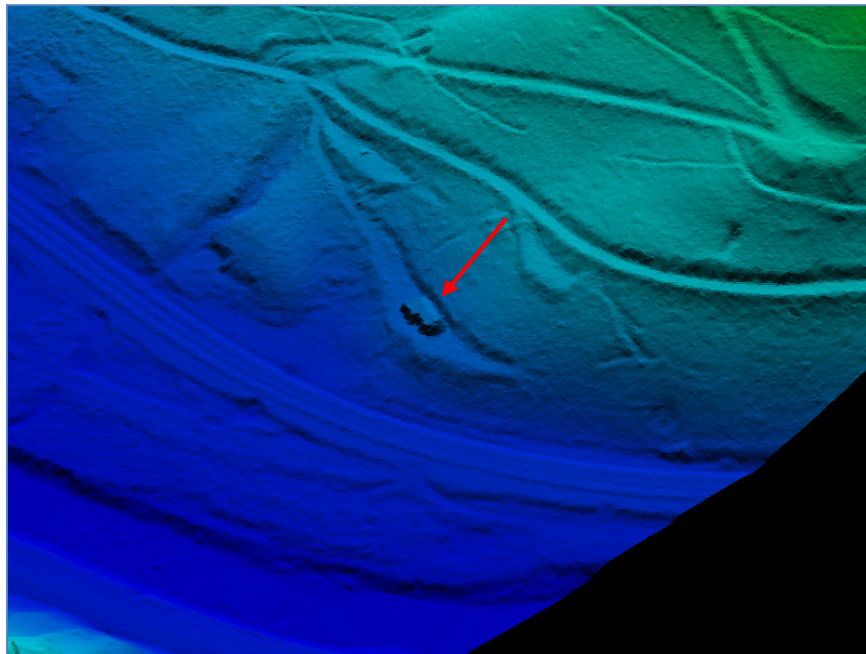
Figure 6: Tile C027654 showing a building artifact

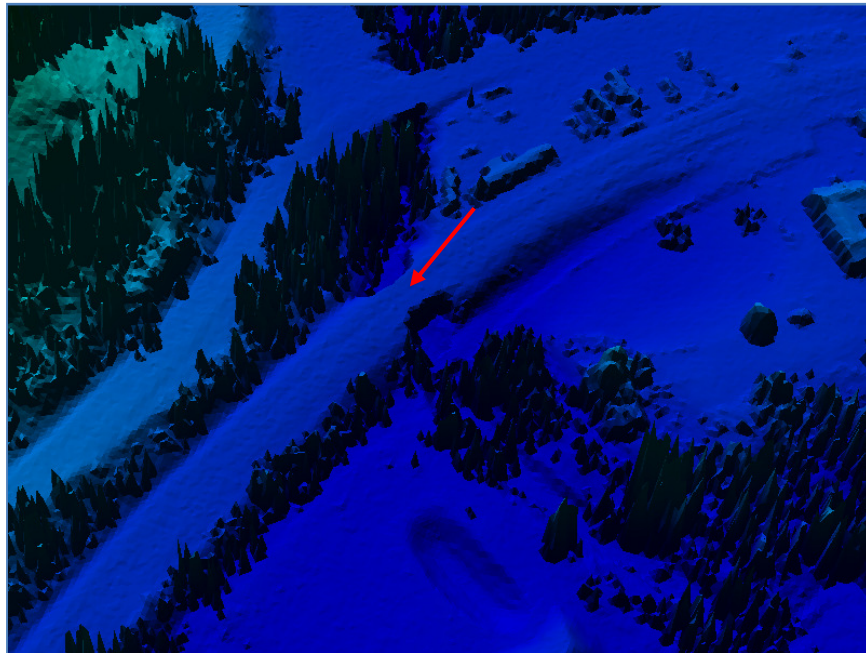
Figure 7: Tile C026594 showing a bridge artifact.

Note that while this image shows the full point cloud, the artifact remains in the ground.

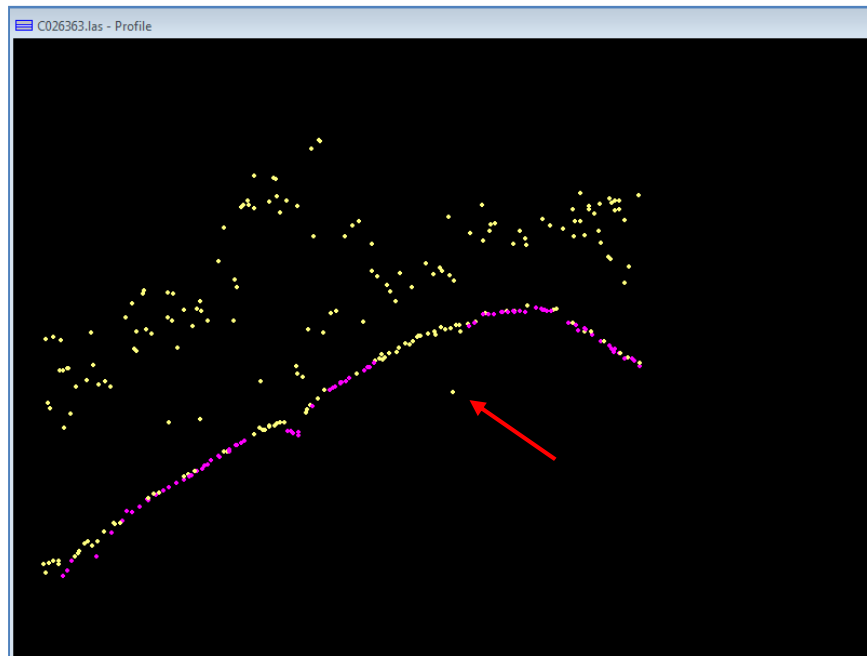
Divots are points that fall far below the expected ground surface. They can occur because of a timing error in the LiDAR sensor or near buildings where the LiDAR pulse is distorted by glass. Because the LiDAR processing software looks for the lowest point near the previously classified ground, the divots are marked as ground and the true ground is treated as non-ground.

Figure 8: Tile C026363 showing a divot that causes misclassification of the ground surface

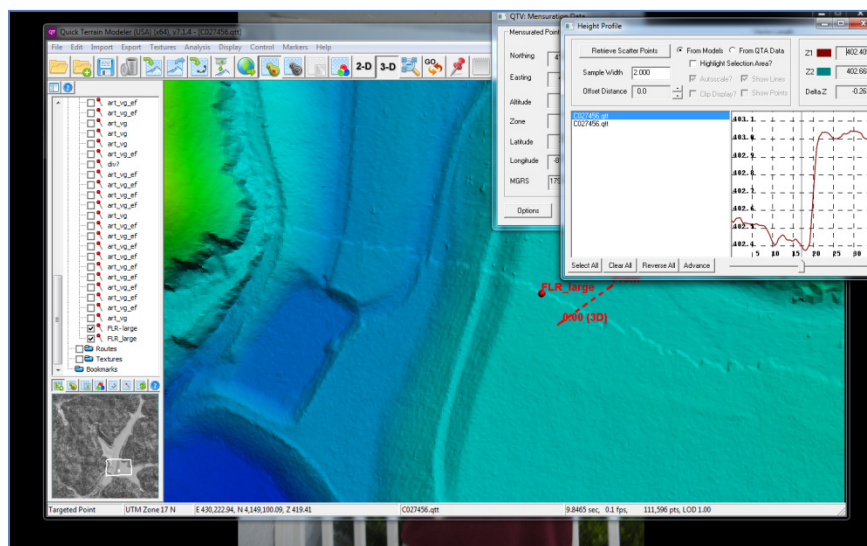
Figure 9: Tile C027456 showing a flight line ridge with an offset of over 0.6 meters

Flight line ridges or seamlines occur when two or more overlapping flight lines are not calibrated correctly. While the review of the Delta-Z ortho images in the completeness check did not find any project-wide calibration errors, several localized issues exist. The data should be recalibrated or reclassified to reduce the ridge to within the accuracy specification set forth in the Statement of Work.

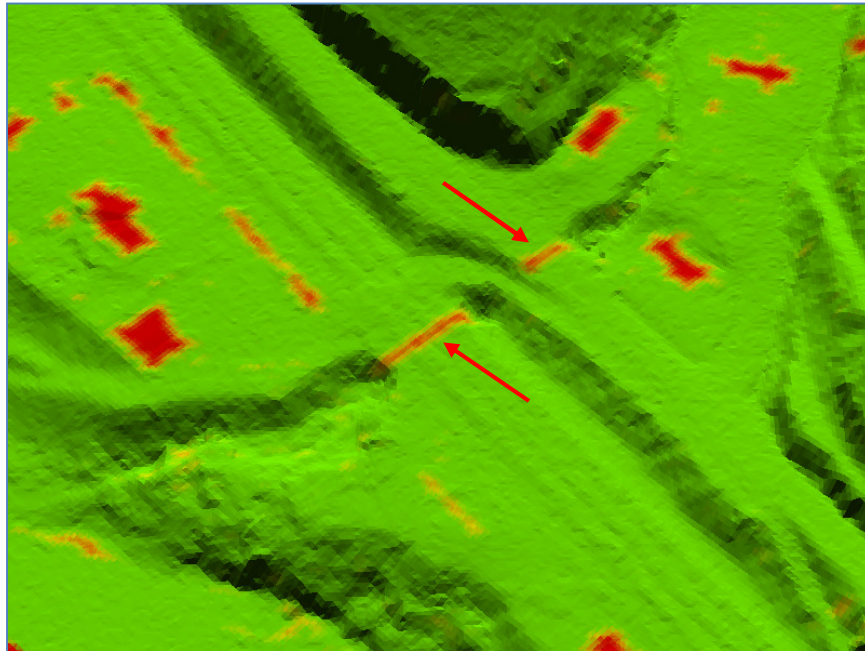
Figure 10: Tile C026478 showing ground points removed from a culvert

A culvert is a feature that allows hydro to flow underneath a road, but unlike a bridge, does not have a man-made deck above the ground surface. A culvert can be differentiated from a bridge because it has visible ground between the road and the hydro surface. As mentioned above in the Artifacts section, culverts should be left in the ground.

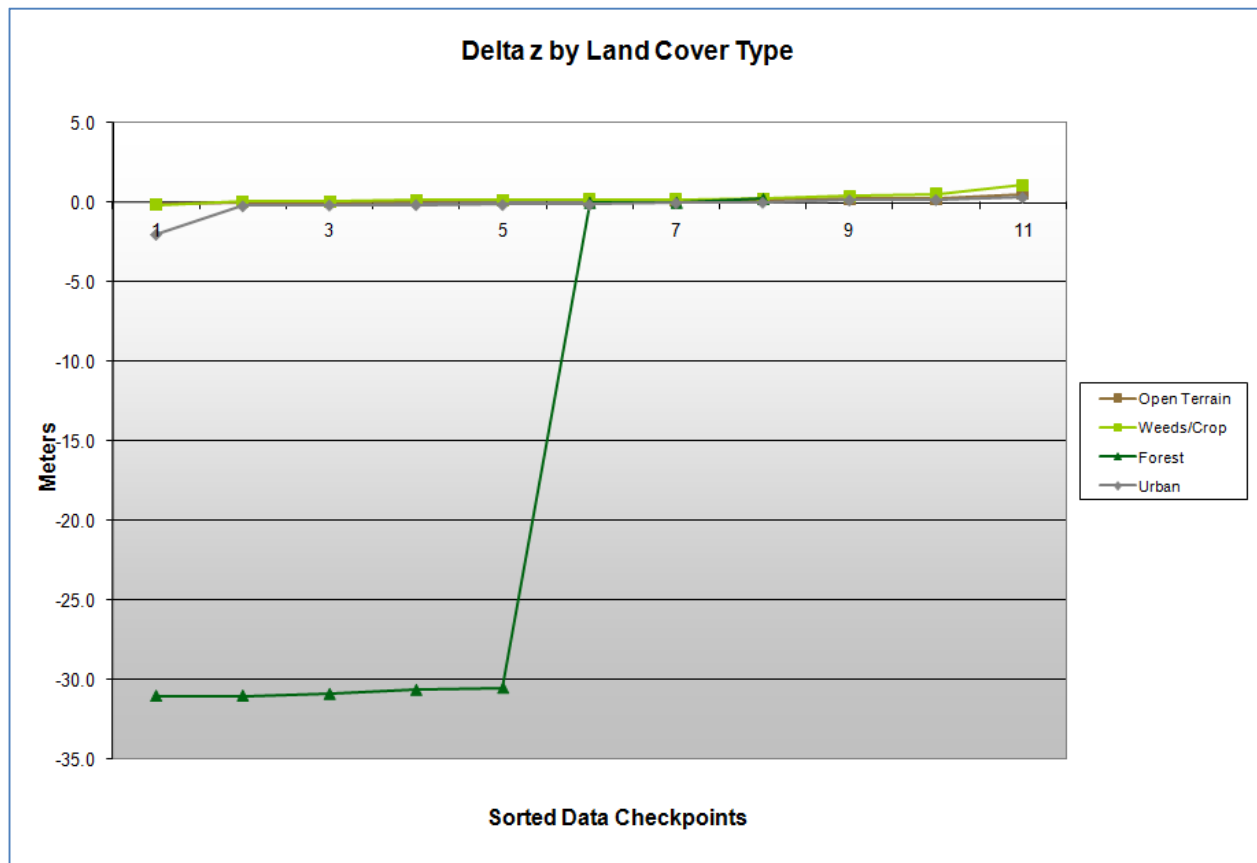
Figure 13: Checkpoint Delta-Z by Land Cover Type

Vertical accuracy was calculated for each land cover type and for the consolidated checkpoints. The Tug Watershed LiDAR does not meet the vertical accuracy requirements due to significant elevation error in some of the tiles.
