**FINAL REPORT ON LANDSLIDES  
OF JULY 9, 1973  
IN KANAWHA CITY AREA  
OF CHARLESTON, WEST VIRGINIA**

**Ronald A. Landers  
and  
Richard A. Smosna**

**WEST VIRGINIA GEOLOGICAL AND ECONOMIC SURVEY  
ROBERT B. ERWIN, DIRECTOR AND STATE GEOLOGIST**

**September 7, 1973**

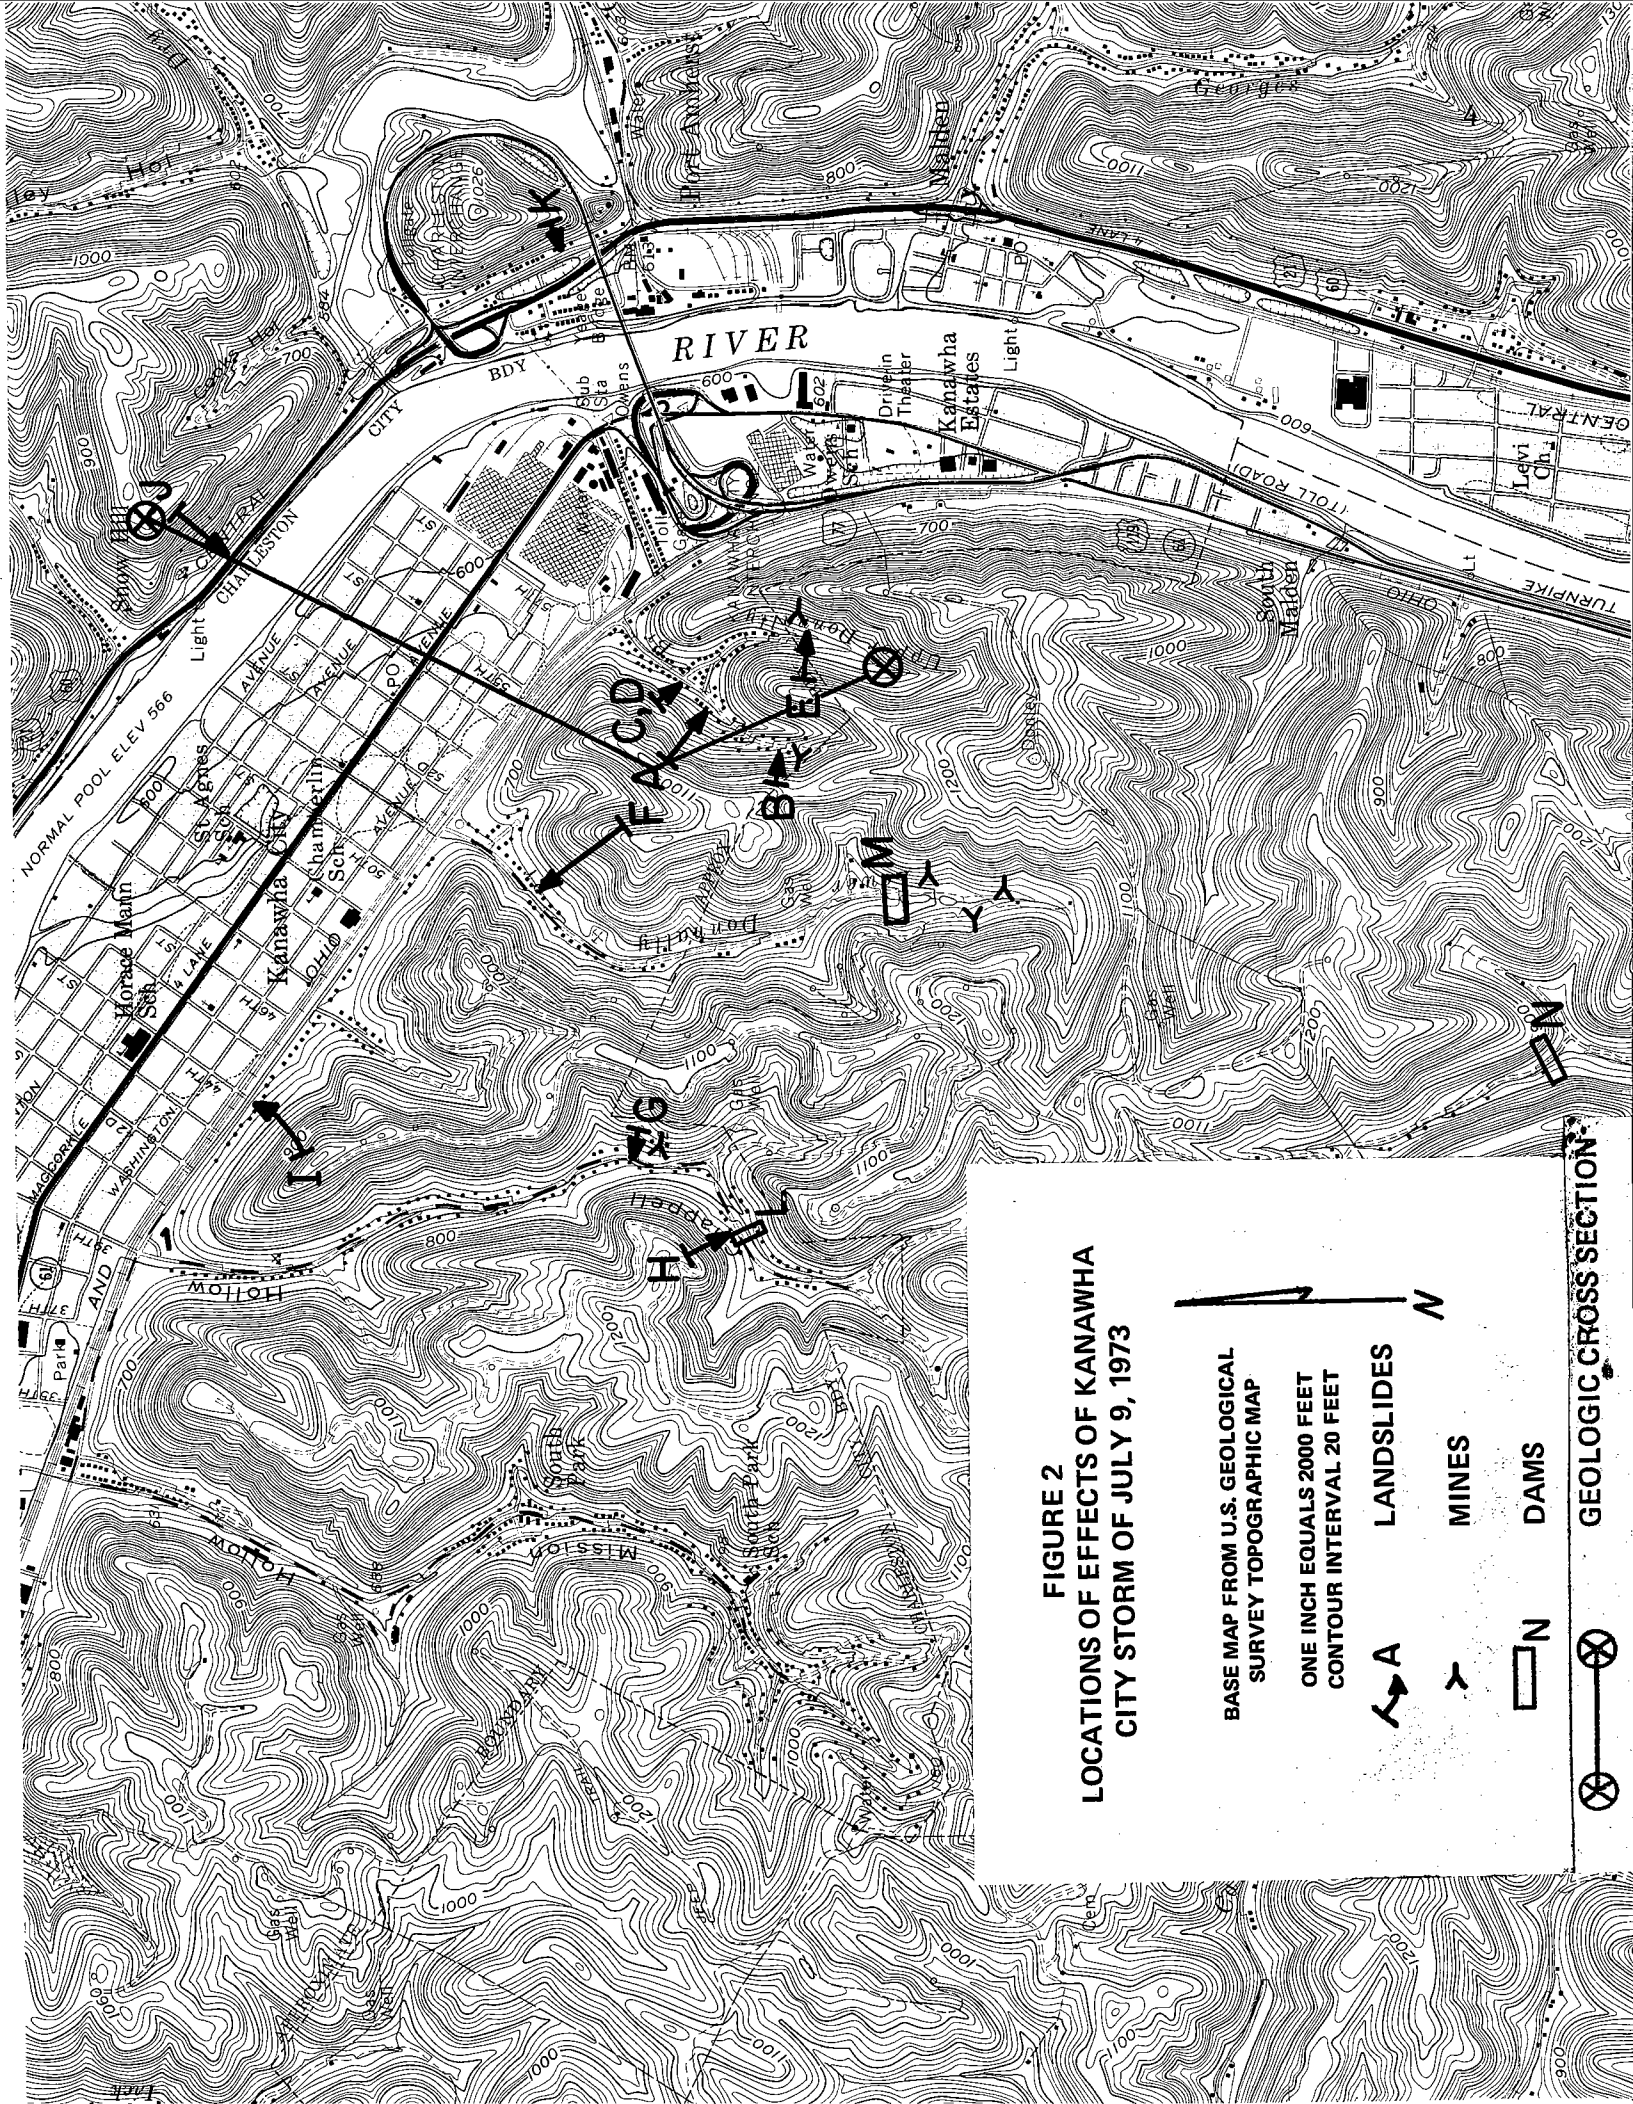
**FIGURE 2**  
**LOCATIONS OF EFFECTS OF KANAWHA**  
**CITY STORM OF JULY 9, 1973**

The locations of the landslides that occurred on July 9 that were examined during the study are shown on Figure 2. The following is a detailed description of the slides, each designated by a letter on Figure 2. In each case, to determine the cause of the slide, the description concentrates on the top of the slide, the point of failure. Table 2 gives some of the dimensions for each slide.

Slide B (Figure 2) occurred behind the house of Woodroe Henderson at 839 Upper Donnally Road. The area where the slide began shows that a semicircular region of 2 feet of soil was removed and slid 50 feet downhill. No evidence of coal or coal mining was found at the point of failure, although the top of a vertical mine airvent is located 35

feet below the top of the scarp. Neither the presence of this vent nor the underlying mine had any effect upon this slide. Slides C and D (Figure 2) are identical to B (50 feet high, occurring at the base of the mountain), except that they began at a lower elevation. Two very similar slides, 15 to 20 feet high, occurred between C and D.

Slide E occurred in the valley of the Left Fork of Upper Donnally Branch. About 3 feet of sandy, rocky soil was removed from above a sandstone ledge in the area where the slide began. The rocks in the immediate vicinity include a massive sandstone that overlies 30 inches of coal, which, in turn, overlies 15 feet of thickly bedded sandstone. This coal is probably the Coalburg coal at the base of geologic unit 3 (Figures 3 and 4).

Slide F (Figure 2) occurred behind the house of Mr. E. Bailey of 722 Lower Donnally Road. In the area where the slide began, apparently a wedge of rocky soil 3 to 4 feet deep by 13 feet wide was removed. This exposed a 15-foot rock cliff. Sandmarks on trees 12 feet out from the base of this wedge showed that the slide was about 12 feet deep, or splashed 12 feet high, at this point. The exposed cliff consists of the same medium-bedded sandstone within geologic unit 2 as noted at the point of failure of Slide A. Approximately 50 feet in front of the base of the removed soil wedge is a rectangular depression, with vertical soil sides, about 7 feet by 4 feet, and covered by at least 1 foot of soil. This may be some type of man-made feature, although no evidence was found for any coal or coal mining in the area.

Slide G occurred behind 866 Chappell Road. The slide is unique in this area because the failure was a rotational slump and occurred along a bowl-shaped curved surface. The slide took place behind a house that

Slide H occurred behind 909 Chappell Road. The point of failure was one of the very few cases in which a slide began where definite human activity had taken place. In this case, the slide originated in the fill beneath a jeep trail. The road itself was saturated with water, which may have contributed to the slide. Bedrock in the cliffs above the road is thickly bedded sandstone with much vertical fracturing and with some shale. The scarp is located near the top of geologic unit 1 (see Figures 3 and 4). Moderately large sandstone boulders were carried down the mountain.

Slide I occurred behind 4405 Chesterfield Road. Halfway down the slope, this slide moved into a pre-existing drainage depression that channelled its direction. Where the slide began, a uniform thickness of about 1 1/2 feet of soil was removed to expose broken sandstone below. There is evidence for much water movement on both sides of the slide scar down the hill. Bedrock in this vicinity consists of thinly bedded sandstone with some shale of unit 2.

Slide J occurred on Snow Hill in eastern Charleston. It is very near, and very similar to, many older slides. At the scarp, about 2 feet of soil was removed. The slide began in sandstone of unit 1 about 60 feet above the level of the Kanawha black flint. The Winifrede coal is exposed about halfway up the slide.

Table 2 summarizes the physical dimensions of these slides. All of the large landslides (A, E, F, H, I, and J) have several common attributes. They all originate at an elevation of about 1,000 feet and less than 100 feet from the top of the hills, and they all began at about the same geologic horizon, the shale of unit 2. The estimated slopes for all these slides are greater than 22°.

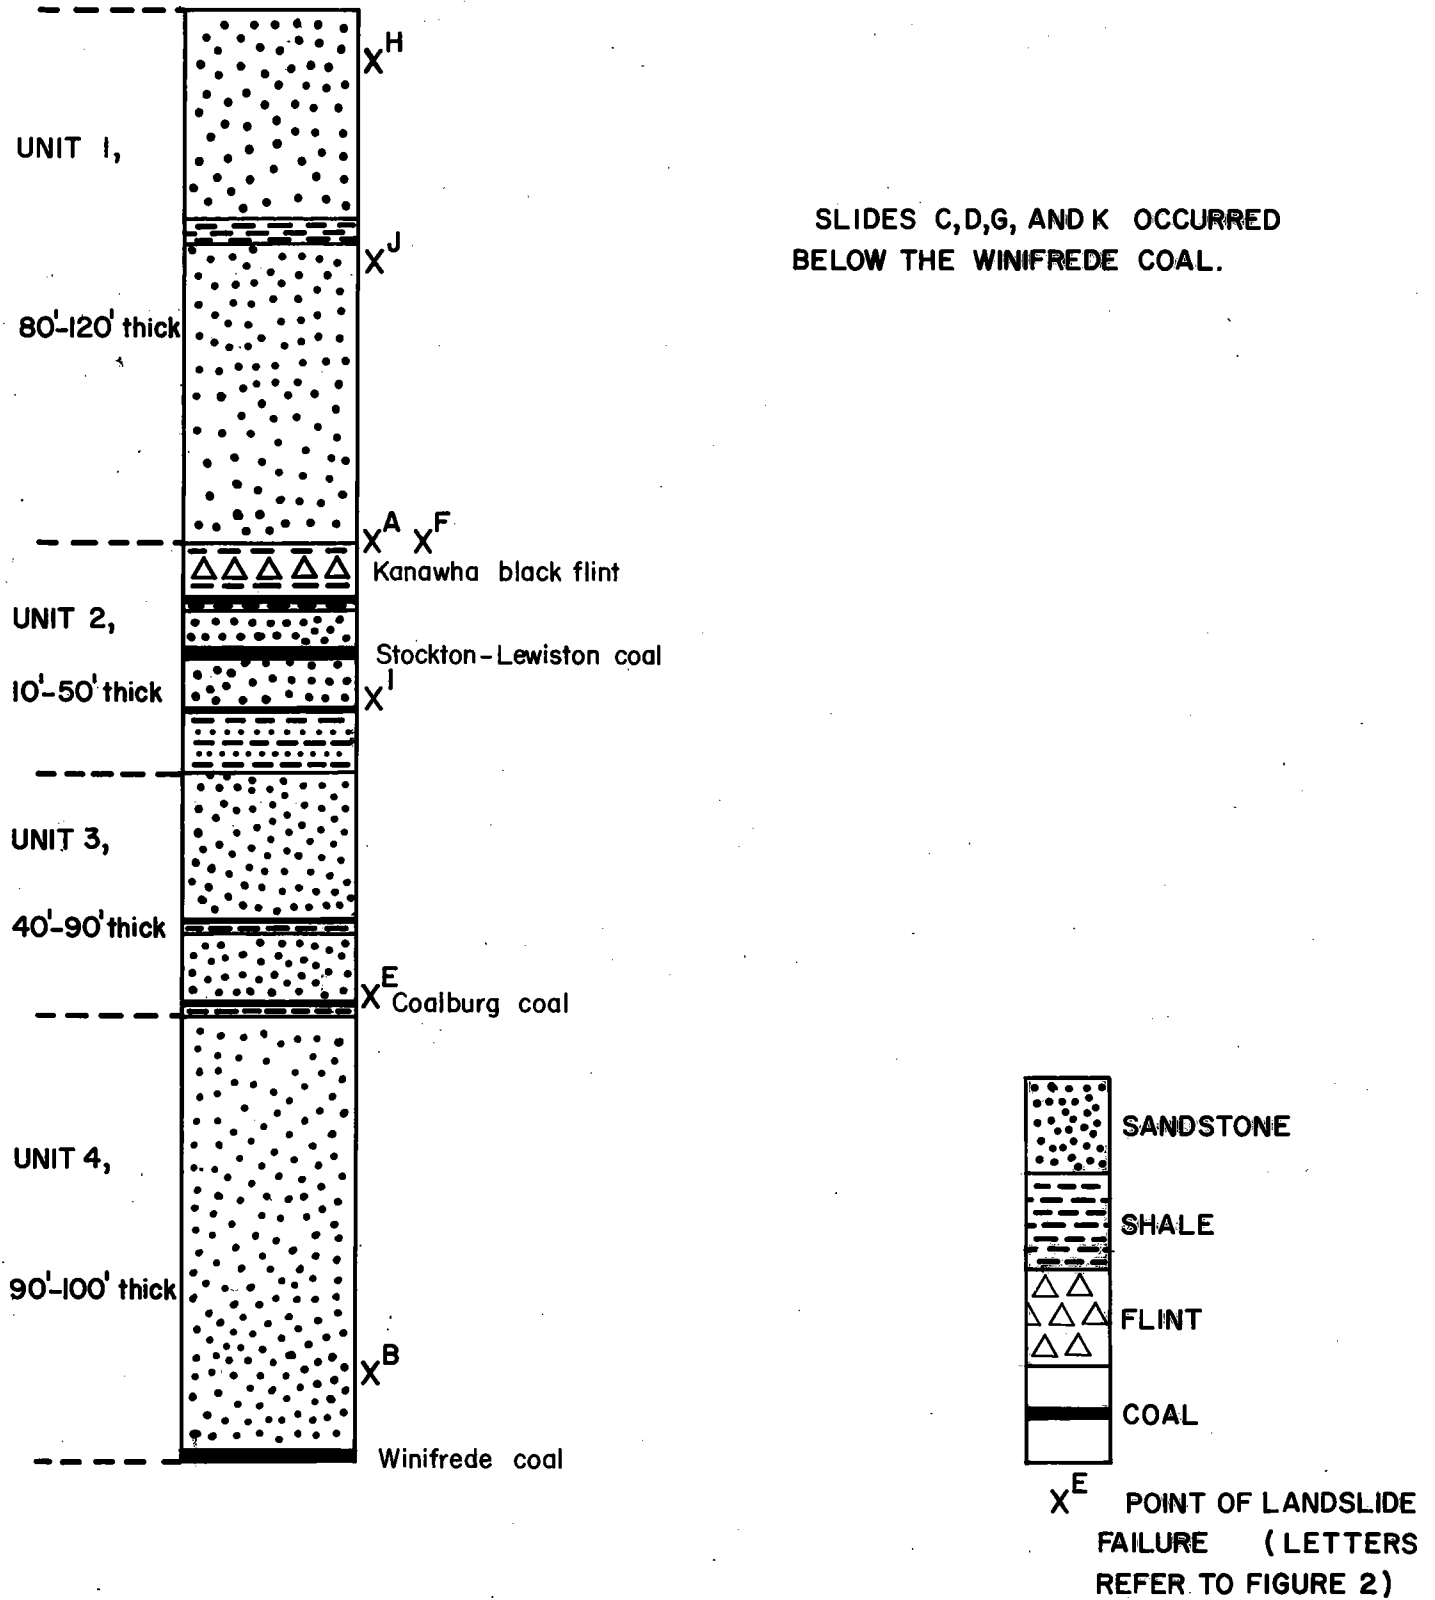
FIGURE 3. GENERALIZED ROCK SEQUENCE IN KANAWHA CITY AND ITS RELATIONSHIP TO LANDSLIDES OF JULY 9, 1973

Unit 1 at the top (see Figure 3) is composed of a massive, slightly fractured sandstone, 80 to 120 feet thick, which caps many of the hills. At a few locations, small sections of the sandstone are exposed as very steep cliffs, but the entire unit is generally covered by soil and vegetation. Near the middle is a thin, shaly sequence. Unit 2 varies from 10 to 50 feet in thickness, but most often is between 30 and 50 feet thick. Although this interval is predominantly alternating sandstone and shale, it also contains: (1) the Stockton-Lewiston coal, 2 to 3 feet thick (strip mined on Rush Creek to the south); (2) one or two other minor coal seams; and (3) the Kanawha black flint. Unit 3 con-

sists of massive sandstone with the 30-inch-thick Coalburg coal at its base. Up to three minor coals with underclays are associated with the Coalburg. This unit varies in thickness from 40 to 90 feet. Unit 4 is a thick sandstone overlying the Winifrede coal. The sandstone is 90 to 100 feet thick and the Winifrede coal is approximately 2 to 3 feet thick.

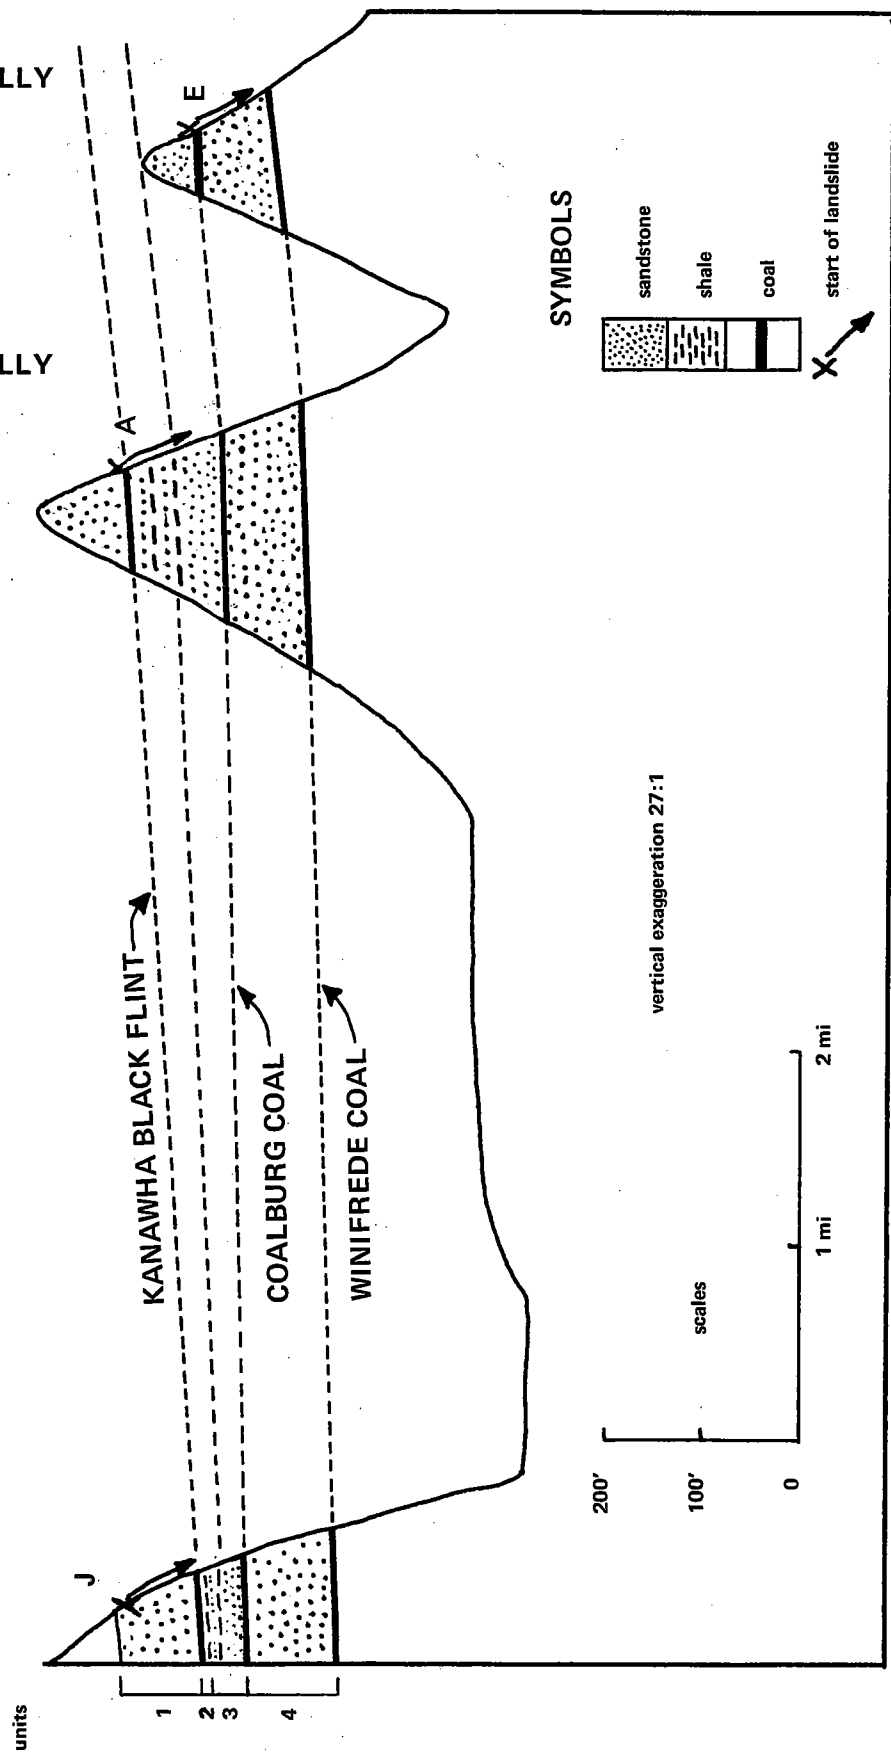
Figure 4. GEOLOGIC CROSS SECTION OF KANAWHA CITY AREA

In the immediate vicinity of Upper Donnally Branch, but not associated with the landslides, evidence of former coal mining was discovered. In the Right Fork of Upper Donnally Branch, an airhole to an abandoned mine is located behind the Henderson house (839 Upper Donnally Road) at an elevation of approximately 830 feet. In Lower Donnally Branch, at least three mine openings exist at an elevation of approximately 820 feet. In Chappell Hollow, an old mine opening was observed behind the Peak house (866 Chappell Road) at an elevation of approximately 800 feet. The coal that was mined at all of these locations was probably the Winifrede. The vertical position of the Winifrede coal with respect to several landslides is illustrated in Figures 3 and 4.

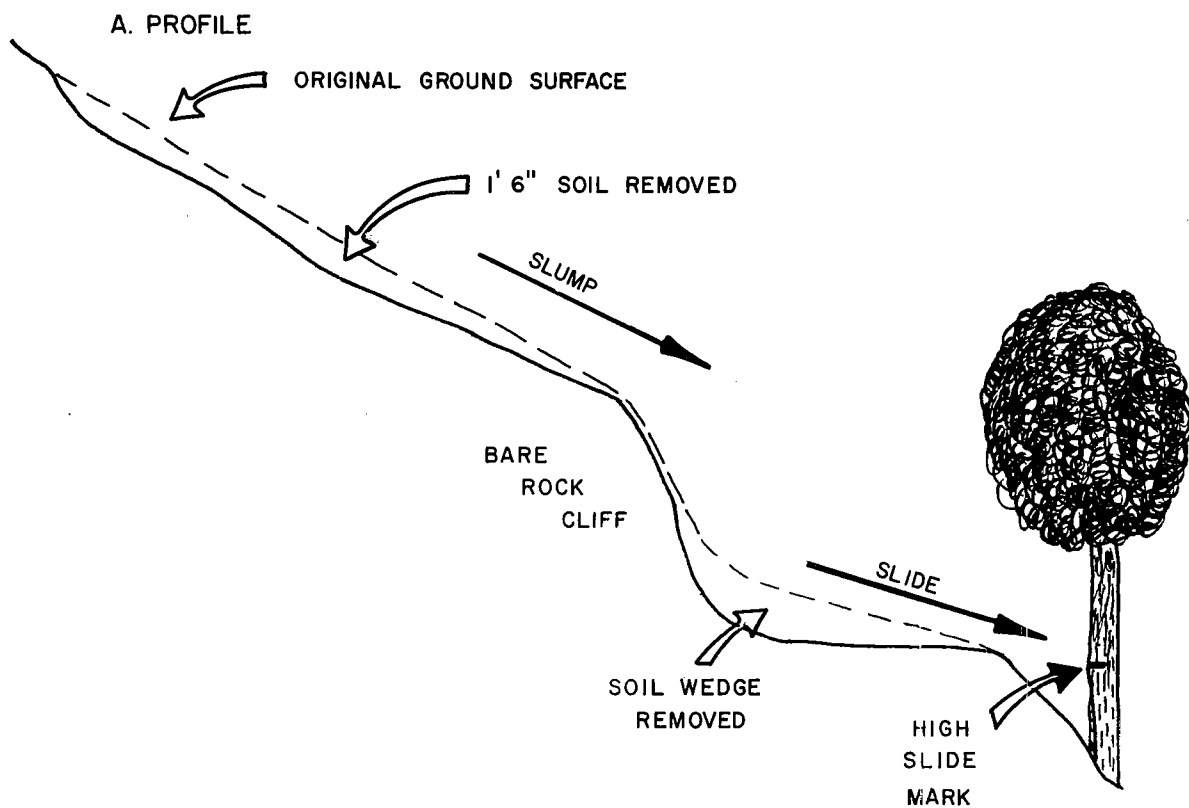
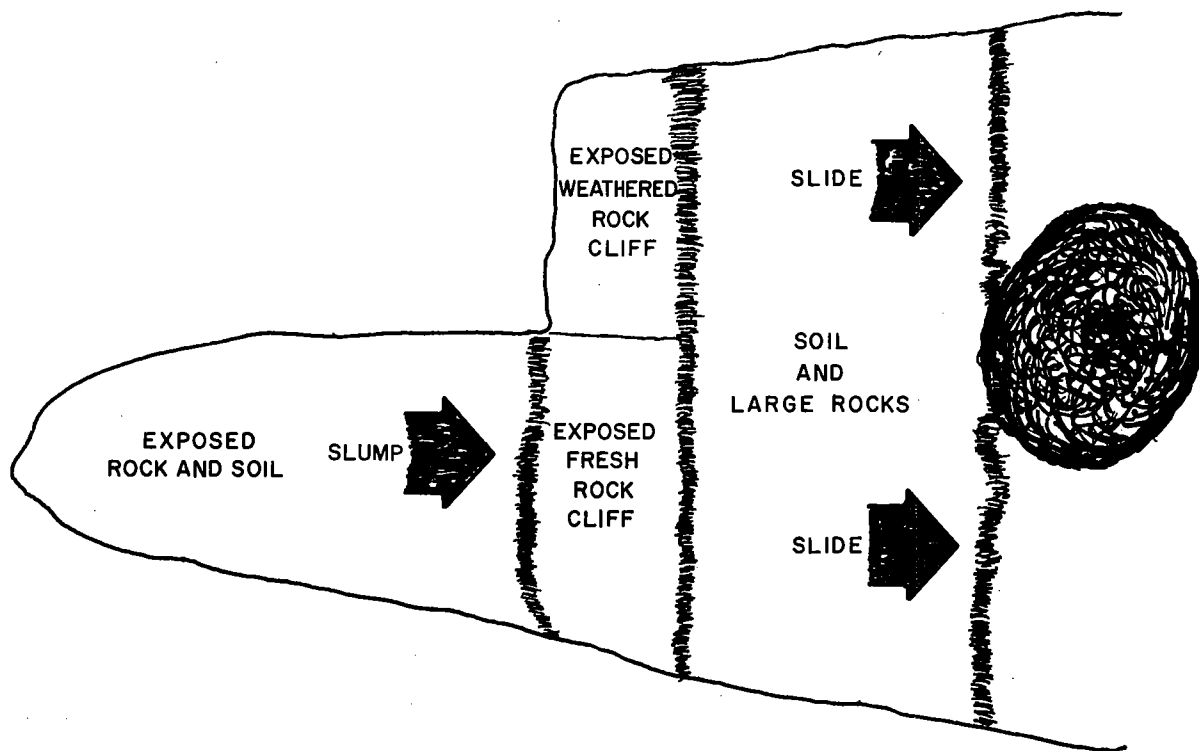
FIGURE 5. SKETCH OF THE TOP OF SLIDE A

Slide A was by far the most destructive event associated with the storm. This slide, unlike the others studied, apparently involved the movement of a wedge-shaped mass of soil (see Figure 5) from the base of the rock cliff, accompanied or followed by the slumping of a thin sheet of soil from higher up the slope. The bedrock underlying the scarp (i.e., the head of the slide) consists of thinly bedded sandstone above the cliff. The cliff itself is thickly bedded sandstone with some vertical fractures. This rock interval is within unit 2 of the generalized rock sequence and is just above the Kanawha black flint and Stockton-Lewiston coal, although these layers are not exposed here. Slopes on either side of slide A are of approximately the same magnitude as the slide area itself; therefore, the slide's starting point was not controlled by a topographic depression. In the area where slide A began, no evidence was found of coal mining--that is, no openings, access roads, or coal debris--although the slide debris may be covering such evidence.

The factors involved in the initiation of the landslides include a combination of geologic, topographic, surface-runoff, and groundwater conditions. The topography in this area is very steep, and the potential for soil and rock erosion and slumping on such terrain is great under normal conditions. The intense storm of July 9, 1973, added an extremely rare amount of rainfall to an existing, naturally-unstable situation. The role of ground water in causing these slides is not completely clear. In the case of slide A, ground water may have been responsible for saturating the wedge of soil before the intense rain.

The generalized regional rock sequence in this area consists of a thick sandstone capping a shale and sandstone sequence. For example, at slide A approximately 100 feet of sandstone (unit 1) overlies a 50-foot sequence of alternating sandstone and shale (unit 2). The low permeability of the shale units prohibited any water that may have percolated down through the soil and the overlying sandstone from contin-

8. A core hole should be made at the top of the hill above the Right Fork of Upper Donnally Branch to determine:
  - a. The exact sequence of rock underlying the hill and the nature of the fractures in these rocks.

- b. The level of the water table.
  - c. The permeability of the rock in place.
  - d. The positions and thickness of any coals that may now be concealed by landslide debris.

This boring should penetrate at least to the level of the Winifrede coal, a depth of approximately 300 feet. The information gained by core drilling can then be used to further assess the problem of large slides at this location. Costs for a drilling contractor for this type of core-hole is in the range of \$5 to \$8 per foot plus setup fees, or about \$2,000 to \$4,000 total costs.
