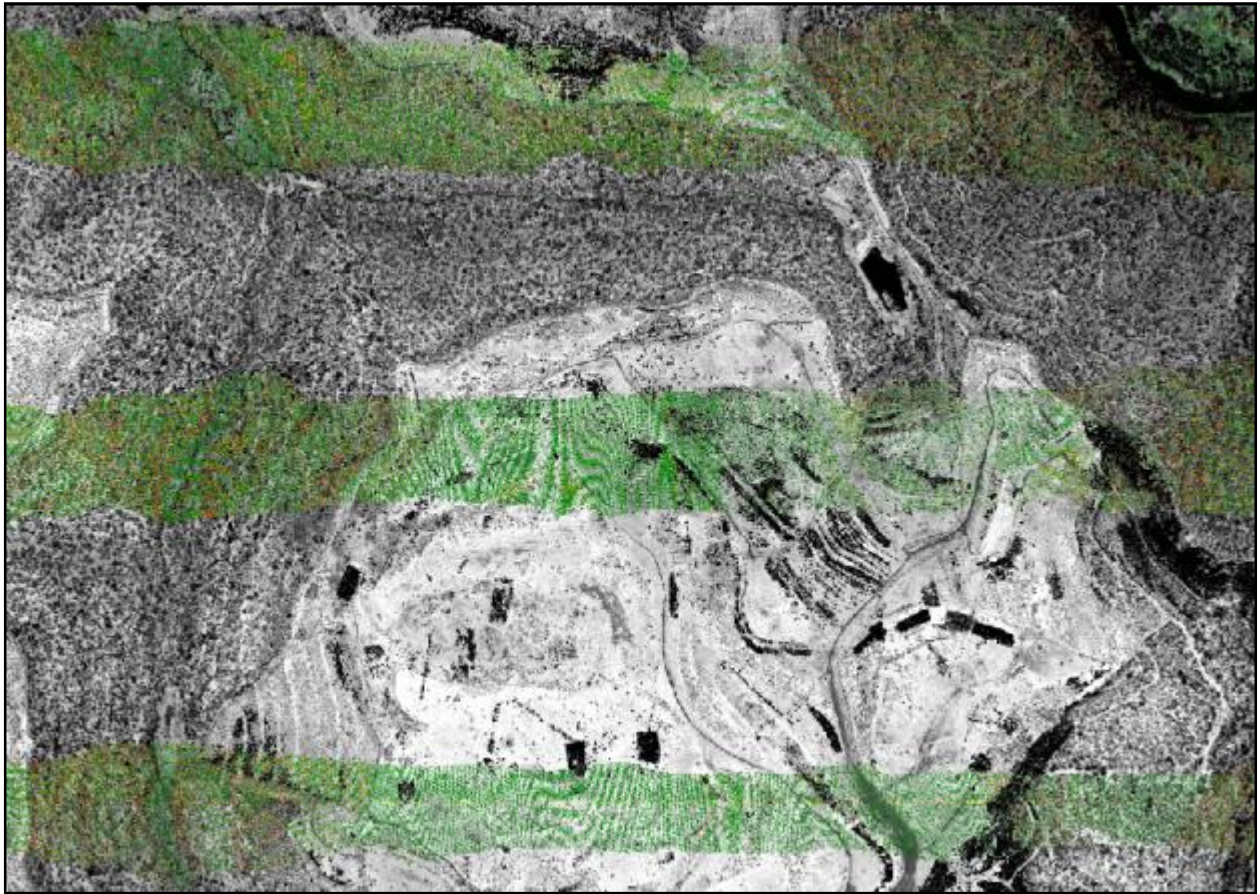
Figure 2 - Delta-Z ortho image of tile C16767.

In the image above, the pixel size was 2 meters and the error gradient was 0.15 meters, meaning the green pixels have an error value of less than 0.15 meters, the yellow pixels have an error of 0.15-0.30 meters, and the red pixels have an error of greater than 0.30 meters. Due to the extremely high relief in the project area many of the pixels showing large elevation errors are not a reliable measure of possible calibration issues. In this situation a higher priority was placed on the low-relief areas, such as the areas around the river and along the roads. The image above is a good example of the quality of the Third Delivery dataset, where a low delta-Z error is prevalent in the low-relief areas around the river and along the roads.

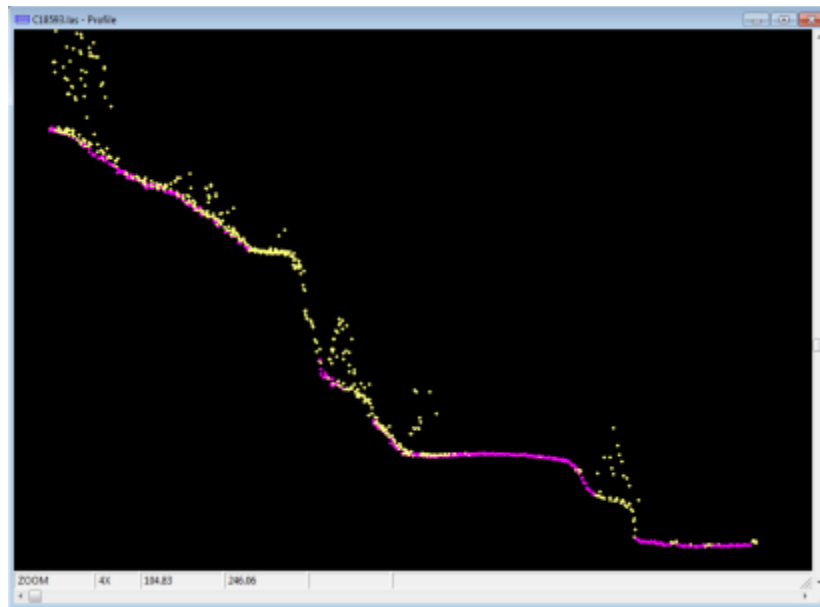
One of the limitations of LiDAR processing algorithms is the ability to differentiate between ground points and vegetation along the edge of a hill or ridge. Since the ground classification algorithm relies on point-to-point distance and angle to determine if a point is ground or non-ground, ground points at the apex of a hill or ridge can be “aggressively” classified out of the ground. Figure 4 below shows ground points in tile C18593 that have been aggressively classified.

Figure 4 - Aggressive Classification in tile C18593. The purple points are ground and yellow are non-ground.

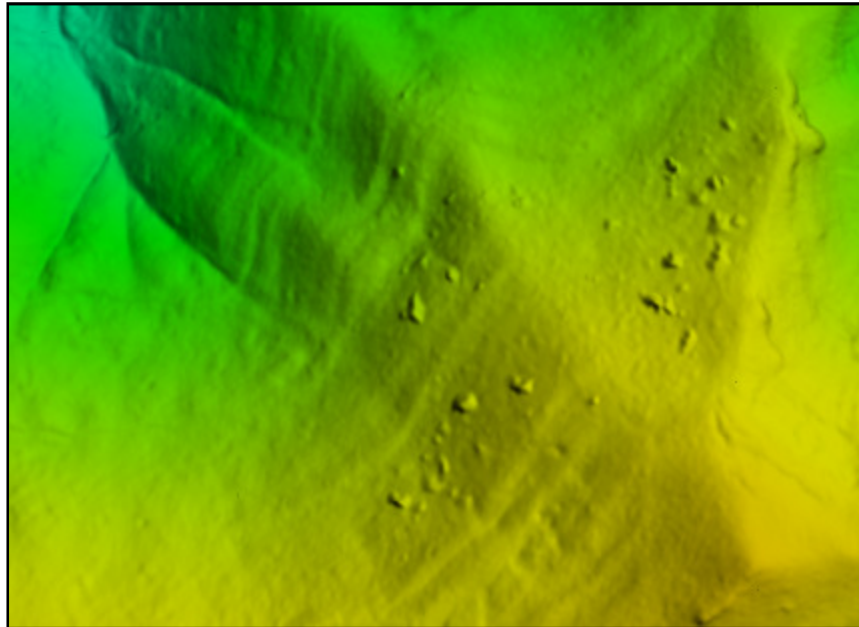
Figure 5 - Tile C20264 showing vegetation artifacts along the side of the hill

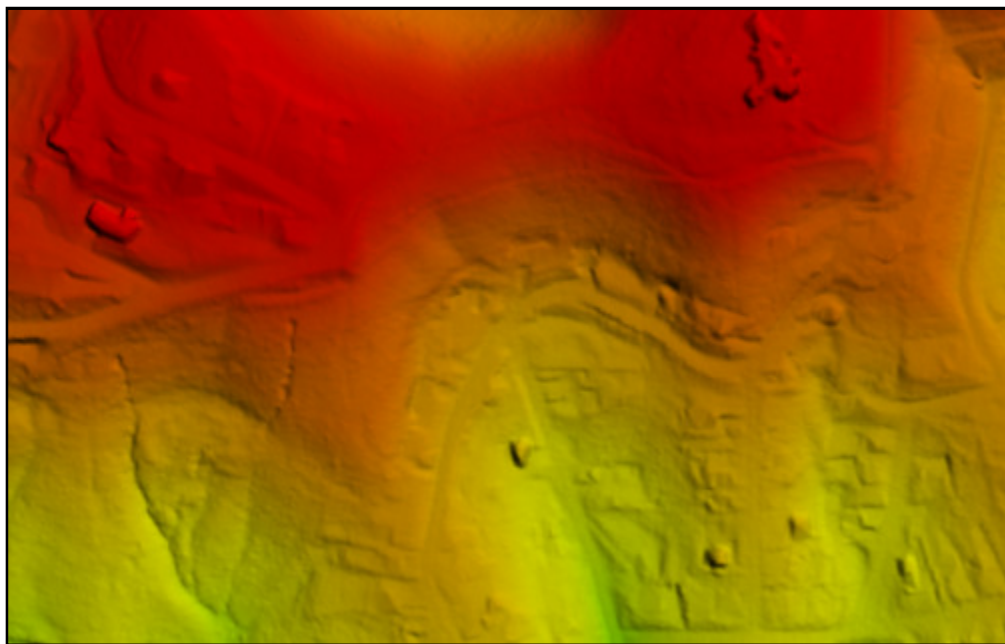
Figure 6 - Tile C18425 showing several building artifacts left in the ground model.

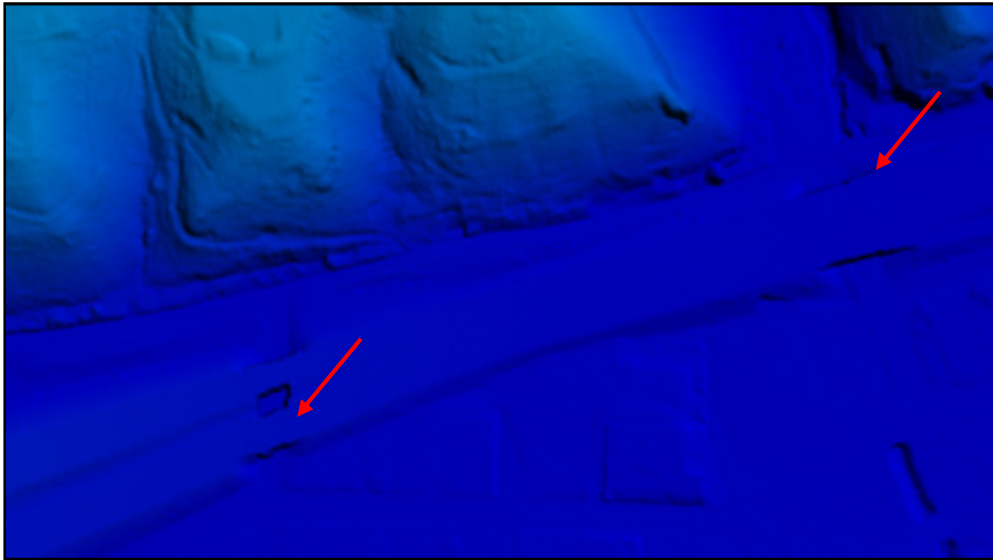
Figure 7 - Tile C18425 showing three bridge artifacts.

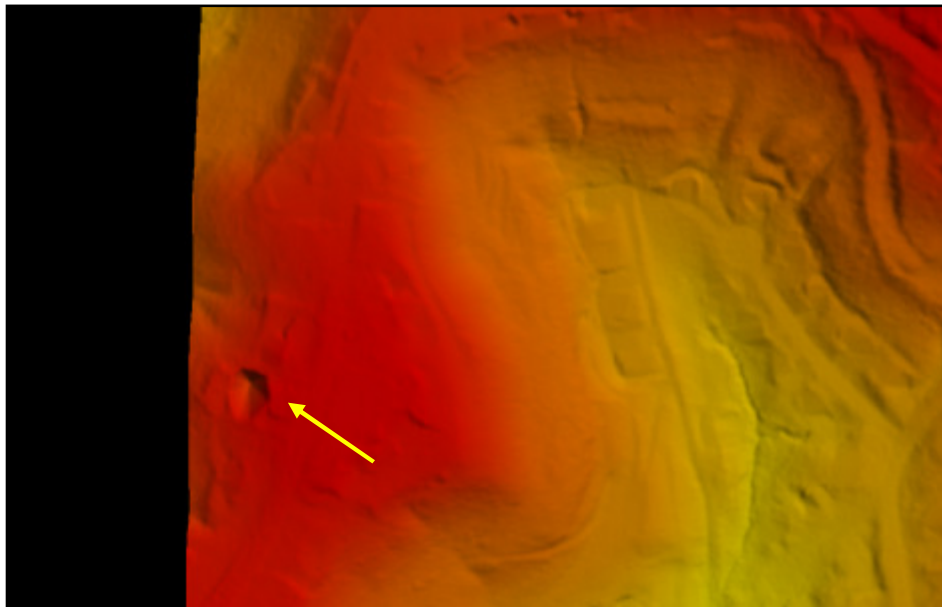
Divots are points that fall far below the expected ground surface. They can occur because of a timing error in the LiDAR sensor or near buildings where the LiDAR pulse is distorted by glass. Because the LiDAR processing software looks for the lowest point near the previously classified ground, the divots are marked as ground and the true ground is treated as non-ground.

Figure 8 - Tile C18592 showing a divot that causes misclassification of the ground surface

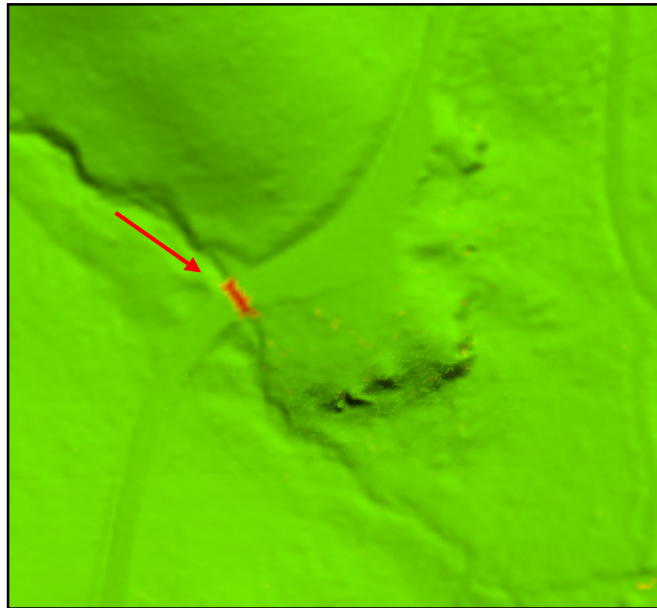
A culvert is a feature that allows hydro to flow underneath a road, but unlike a bridge, does not have a man-made deck above the ground surface. A culvert can be differentiated from a bridge because it has visible ground between the road and the hydro surface. As mentioned above in the Artifacts section, culverts should be left in the ground.

Figure 9 - Tile C18492 showing ground points removed from a culvert

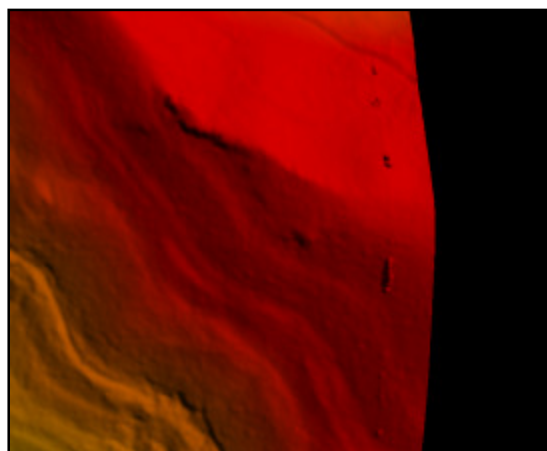
Overlap in tiles resulted in inconsistent editing along the tile edges. Many tiles contained vegetation and structure artifacts in these overlapping areas. Figure 10 shows a line of artifacts that were left along the western edge in the ground density model of tile C20585.

Figure 10 - Vegetation artifacts along the edge of a tile.

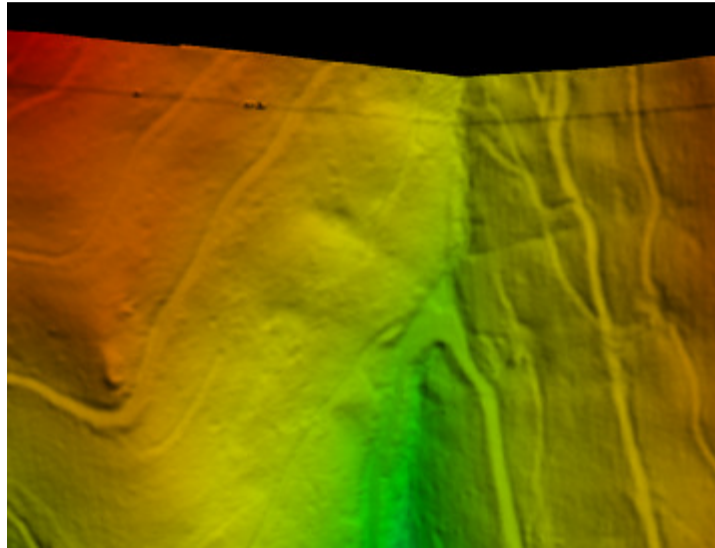
In a few cases, a ridge appeared in the overlapping areas. This signifies a change in ground elevation from one tile to the next and is likely a result of flight line offsets. Figure 11 shows a ridge in the overlapping area between tiles C20427 and C20266.

Figure 11 - A ridge formed in the overlapping area between tiles.

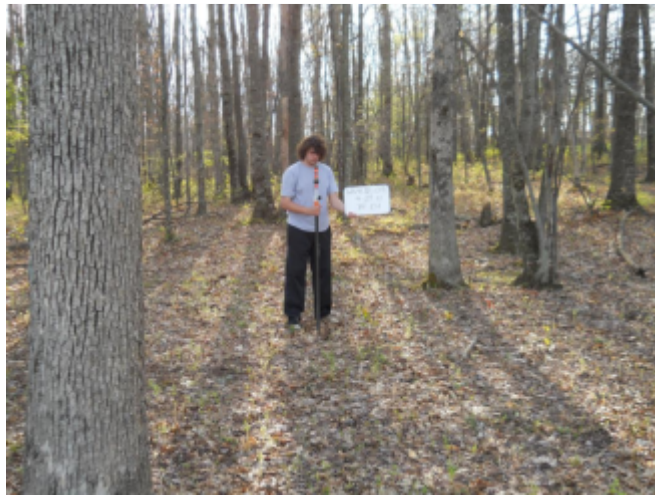
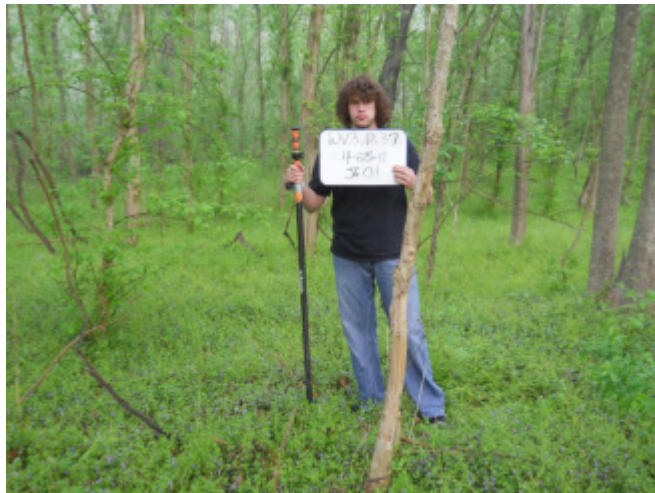
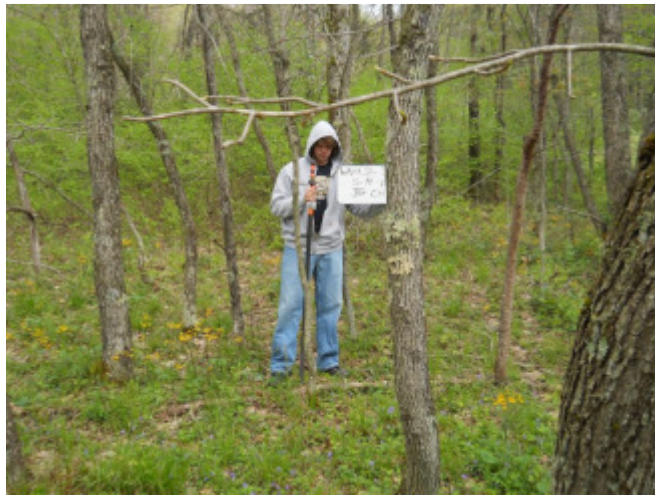
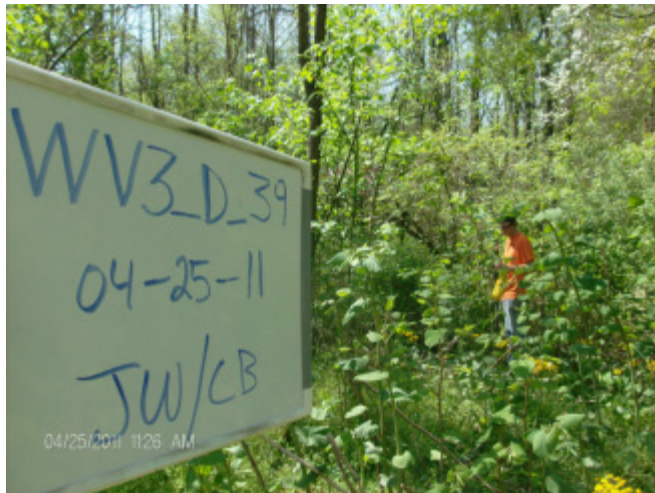
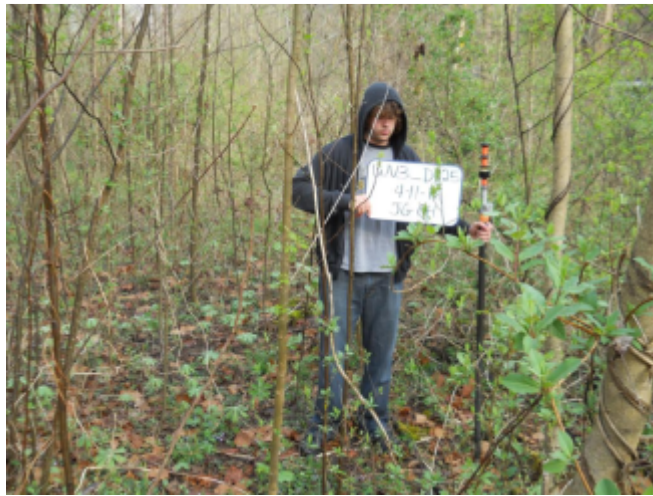
All of the removed points can be seen in the images below. These points were removed from the RMSE due to their located in heavily vegetated areas. The difference between the checkpoint elevations and the LiDAR elevations for the removed points were all higher than 2.5 meters, which suggests a possible survey issue on those specific points or an error in ground classification.
