# Known Historic Flood Heights at Various Locations in Marlinton, WV

Assembled by Kevin Stitzinger, Deputy Director of Pocahontas County Emergency Management & 911  
February 2024

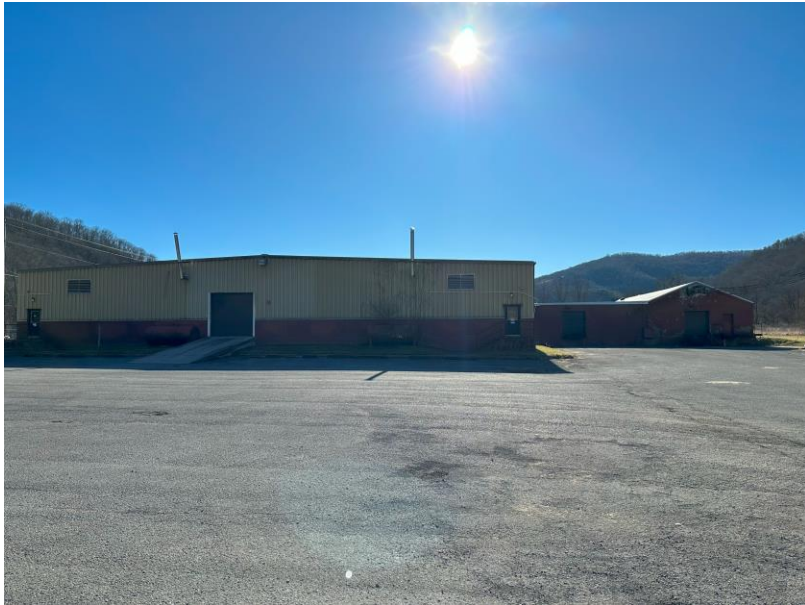
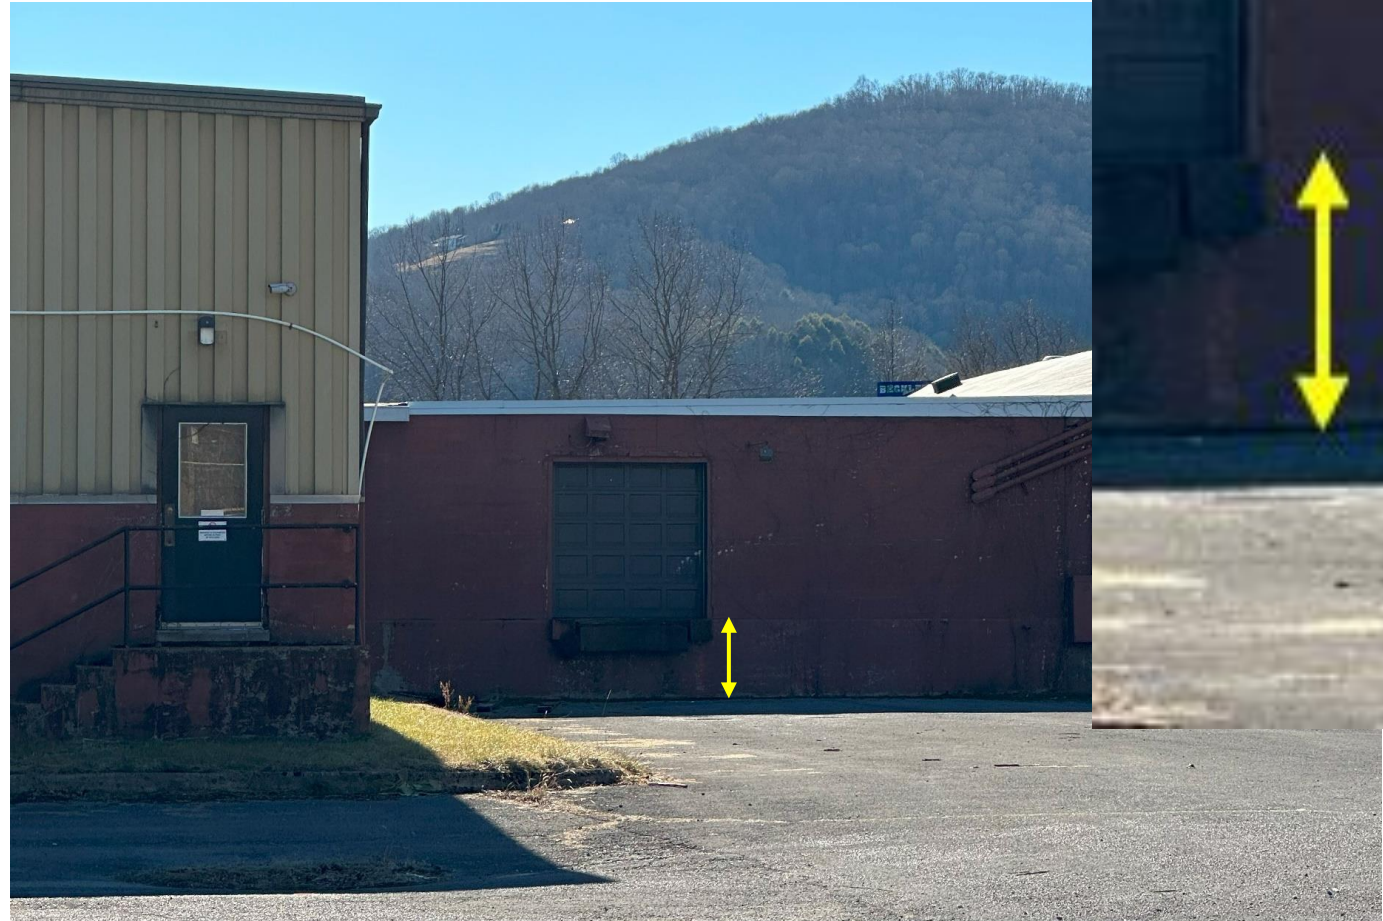
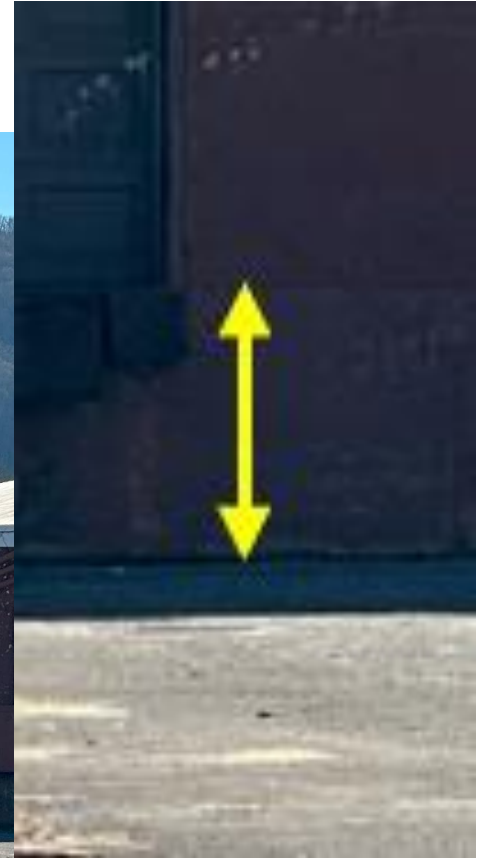
## Former Hanover Shoe Factory – Now called the ARC Building

It has been reported that the building had 3 inches of water in it during the 1985 Flood. This measures to 51 inches above ground level. Measured at the back delivery docks.

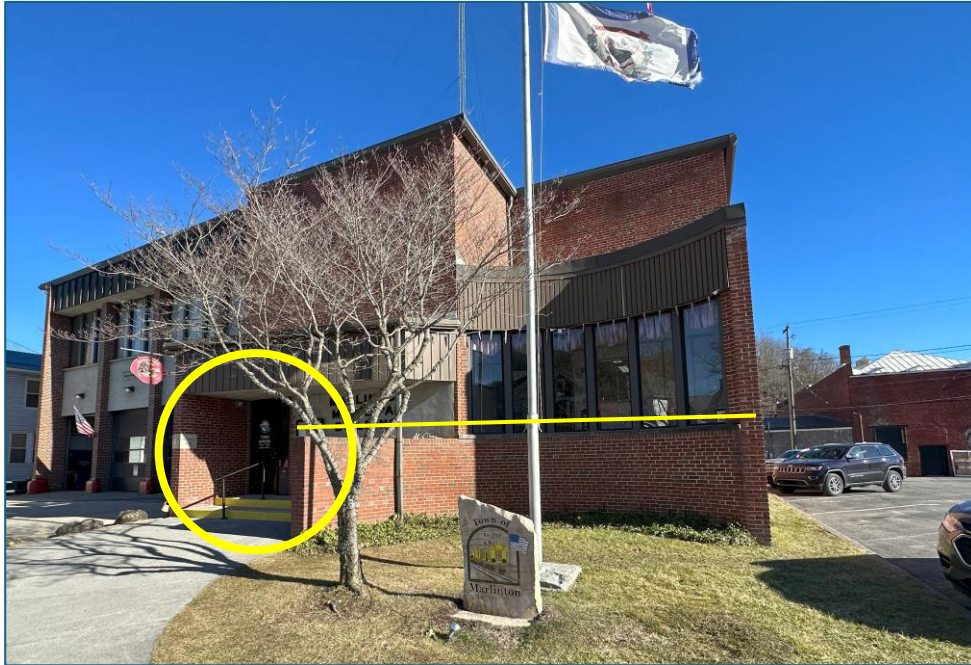
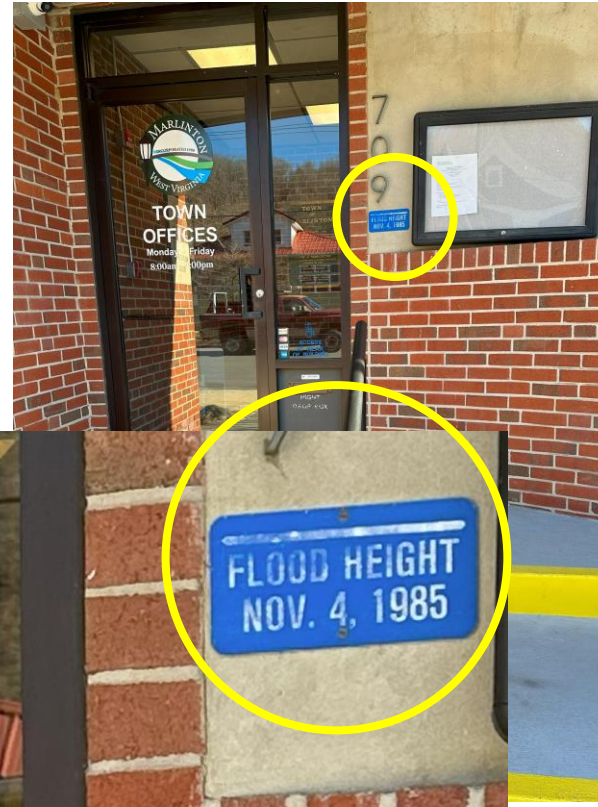
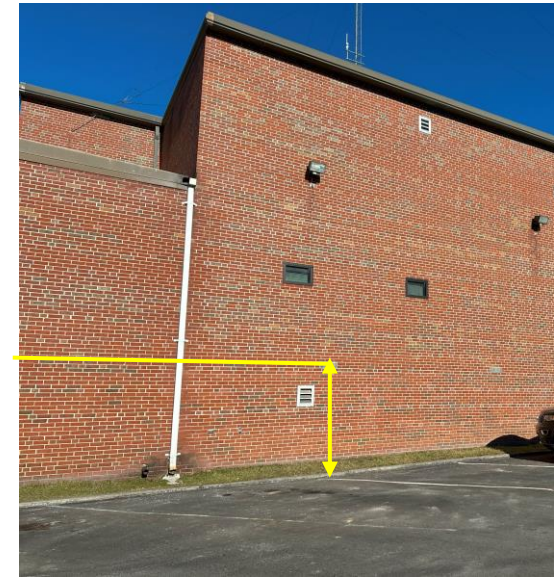
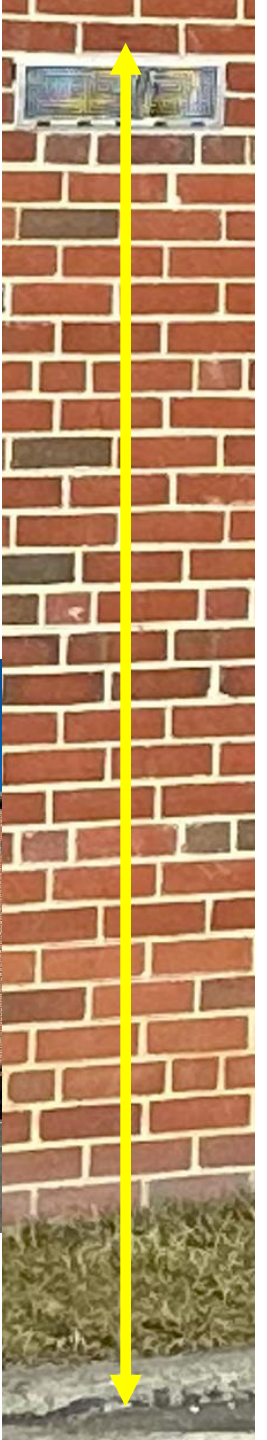
# Marlinton Fire House / Municipal building

**1985** flood height was 84 inches above ground level as indicated by the blue historical flood height marker, which is 8 inches above the top of the brick ledge. I traced that height around to the parking lot shared with the bank. That put the watermark at a half a brick above the wall vent. I measured from that down to the grass and got 82 inches and then measured another 2 inches from the grass to the asphalt parking lot for the curb height. Total equals 84 inches.

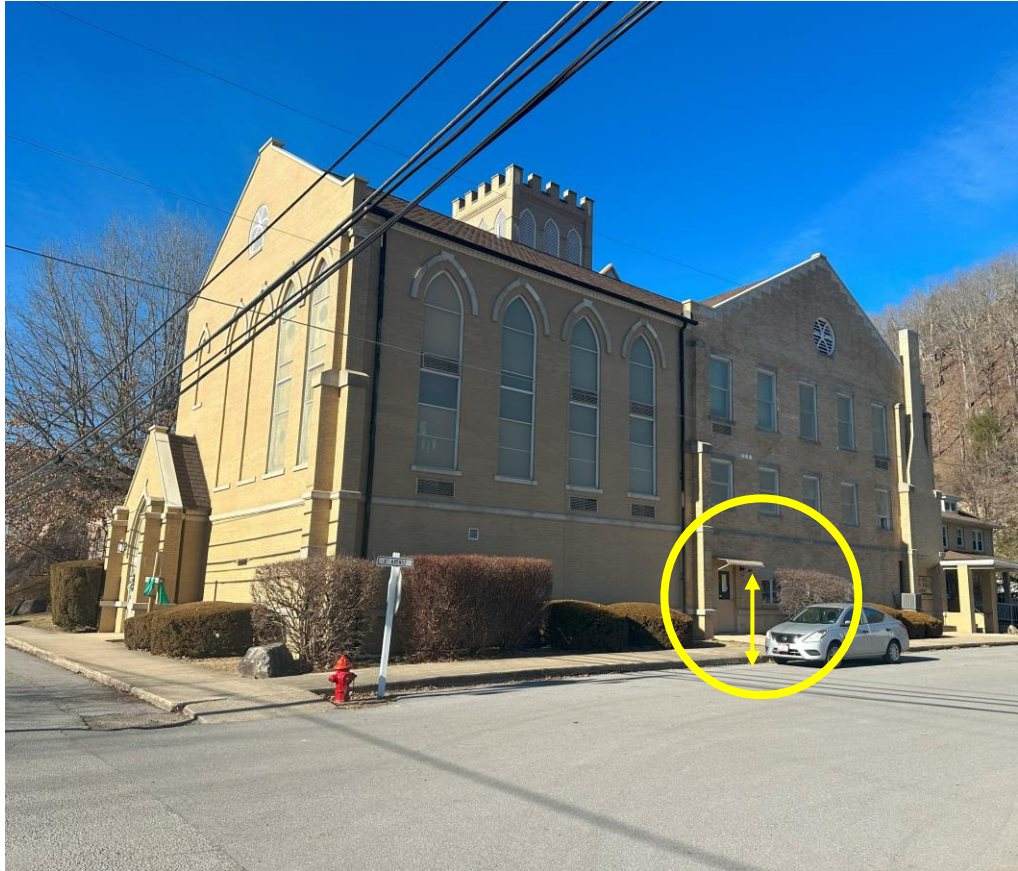
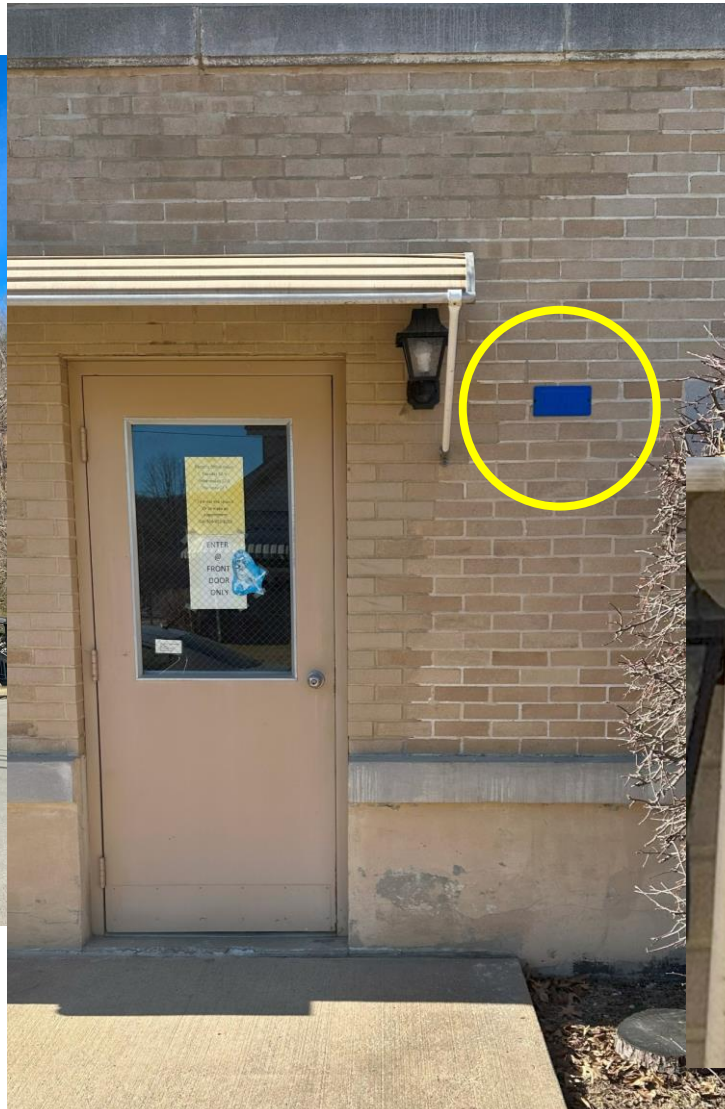
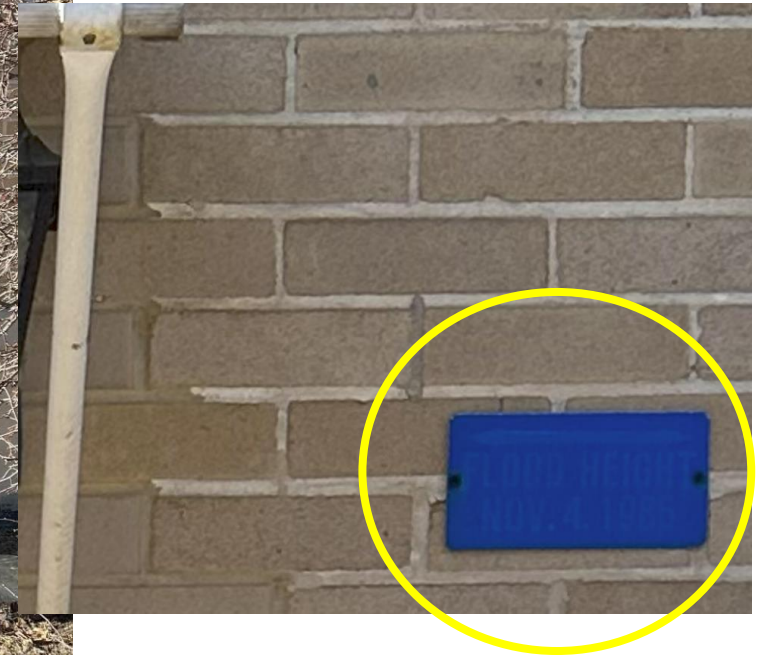
## Marlinton Methodist Church

Measured from the **1985** blue historical marker to street level. Flood height 90 inches above ground level at the street directly in front of the marker.

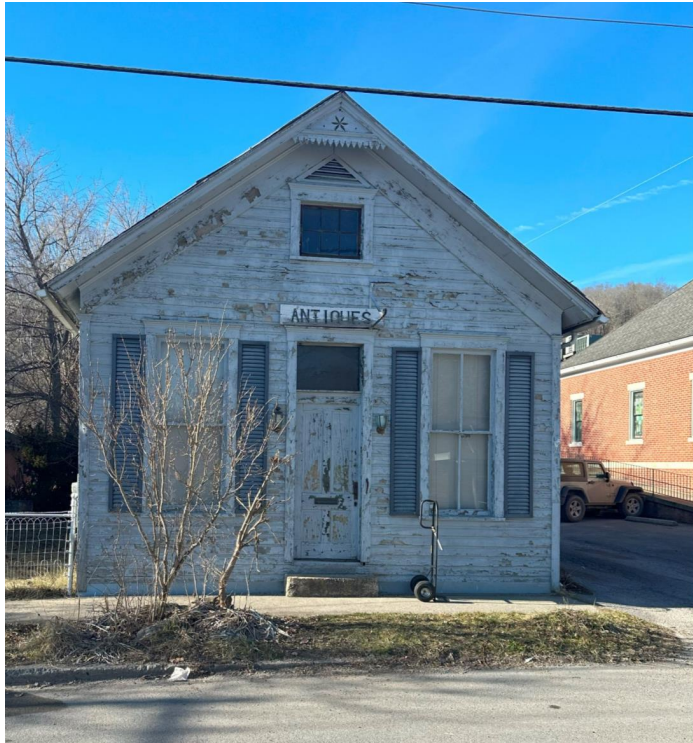
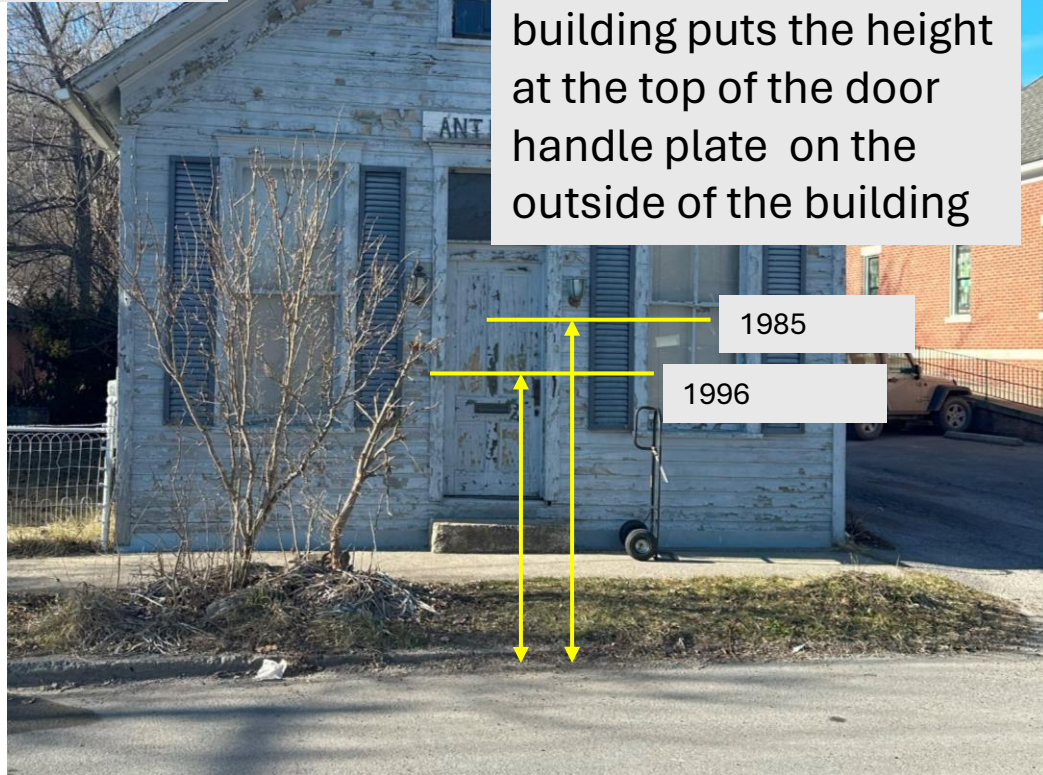
## Former Pocahontas Times office

Both flood heights were measured from the historical marker just inside the door to the floor of the building, then from the floor of the building as seen at the top of the steps to the grass and then from the grass down the curb height to the street level directly in front of the building

**1985** 79 inches above ground level of street directly in front of the building

**1996** 57 inches above ground level of street directly in front of the building

1985 Flood marker on the inside of the building puts the height at the top of the 8 in the address on the outside of the building

1996 Flood marker on the inside of the building puts the height at the top of the door handle plate on the outside of the building

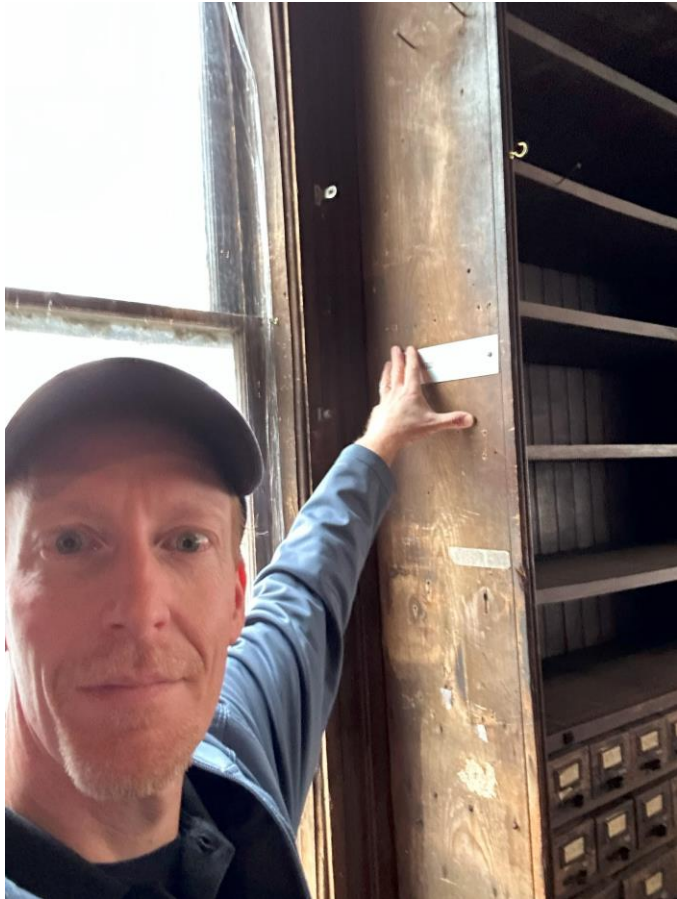
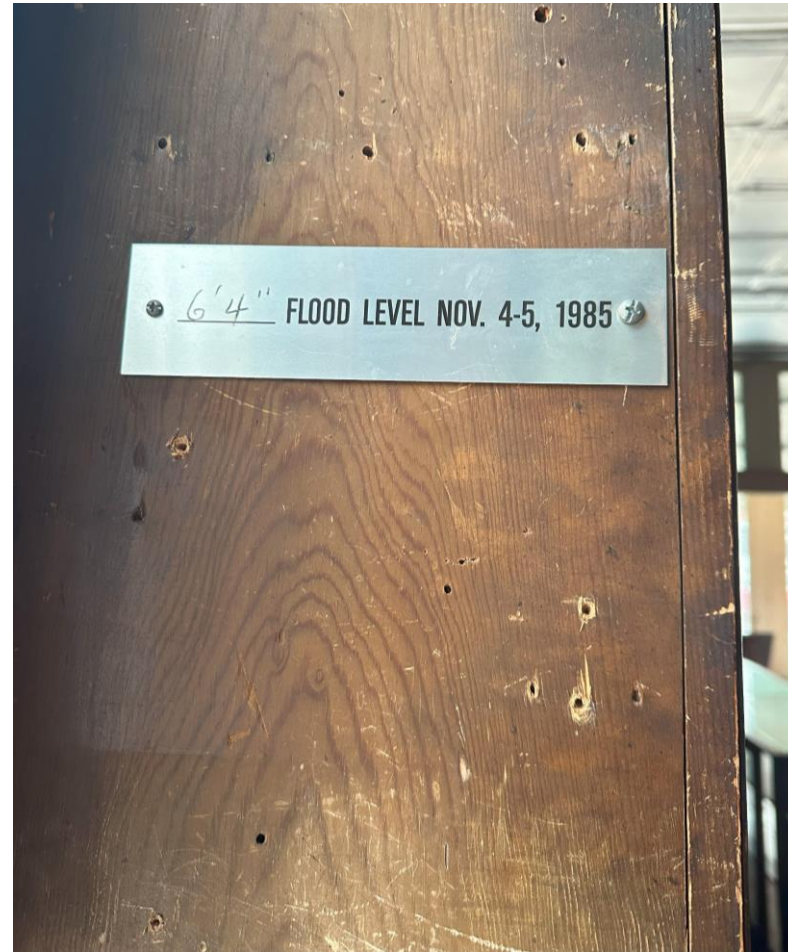
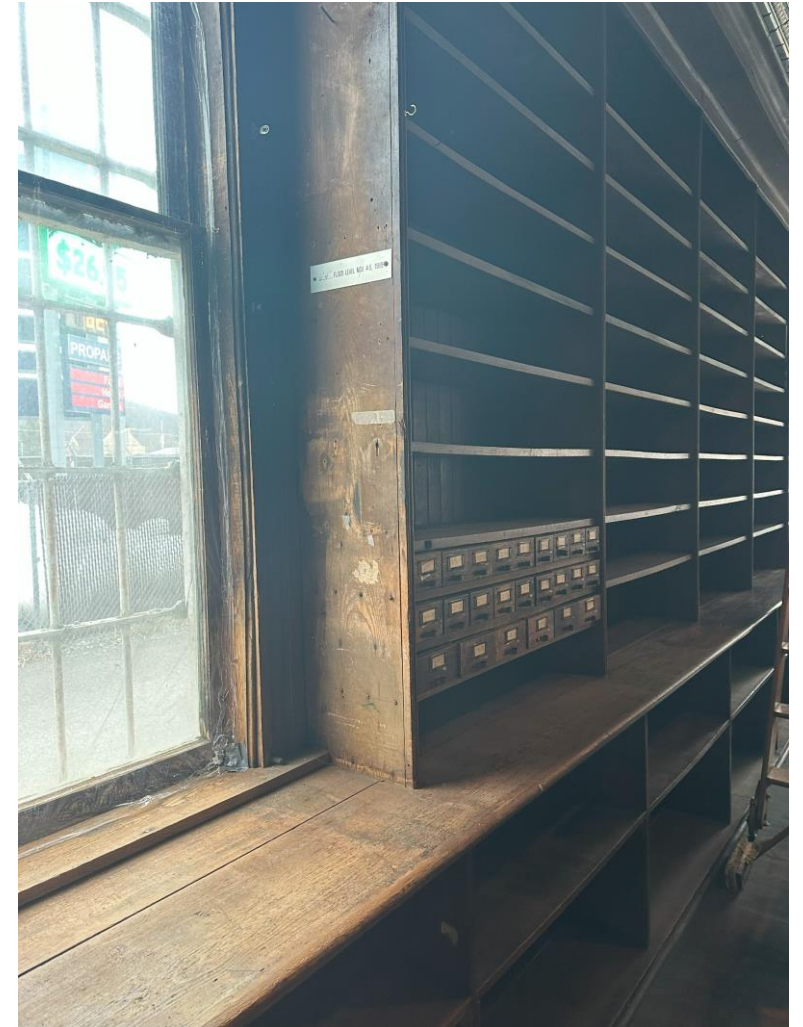
## Former Richardson's Hardware Building – Now Named Rivertown Shops (interior has not been remodeled)

**1985** flood height silver historical marker says 6' 4" which is accurate (76 inches) above the building's hardwood floor. There is a 10 inch rise from the street outside the door up to the floor of the store. Total height equals 86 inches above ground level at the street just outside the door.

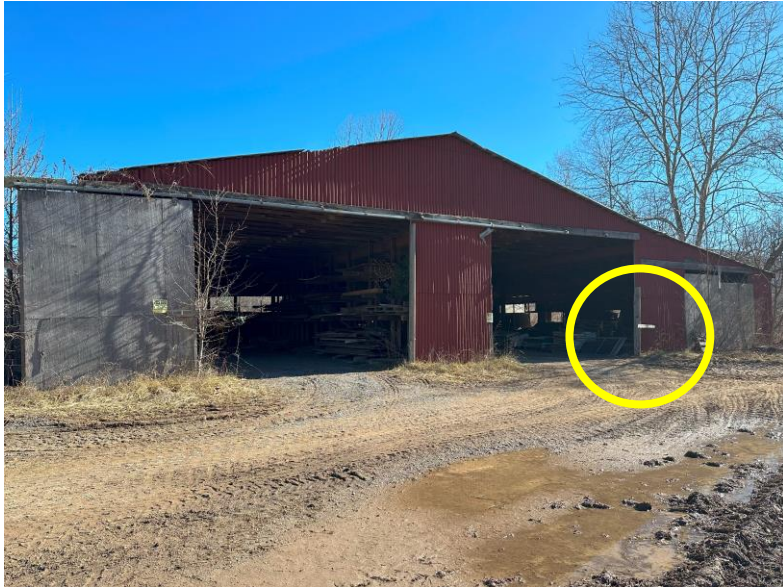
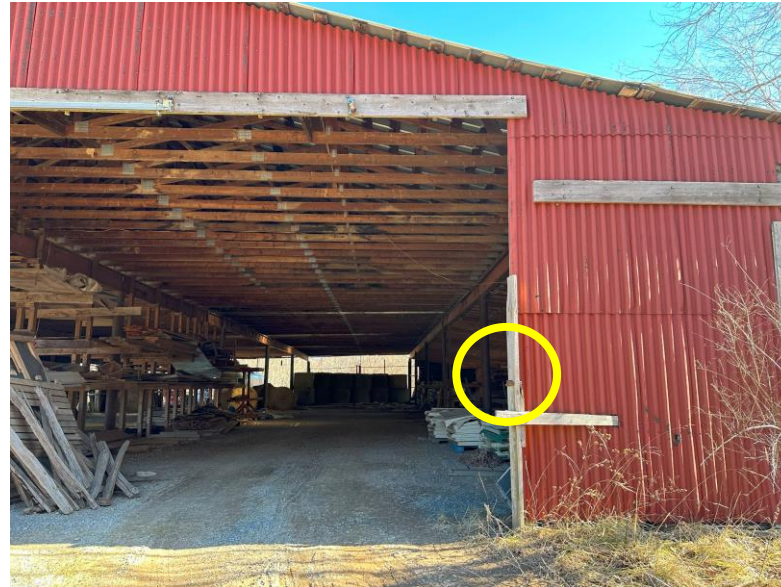
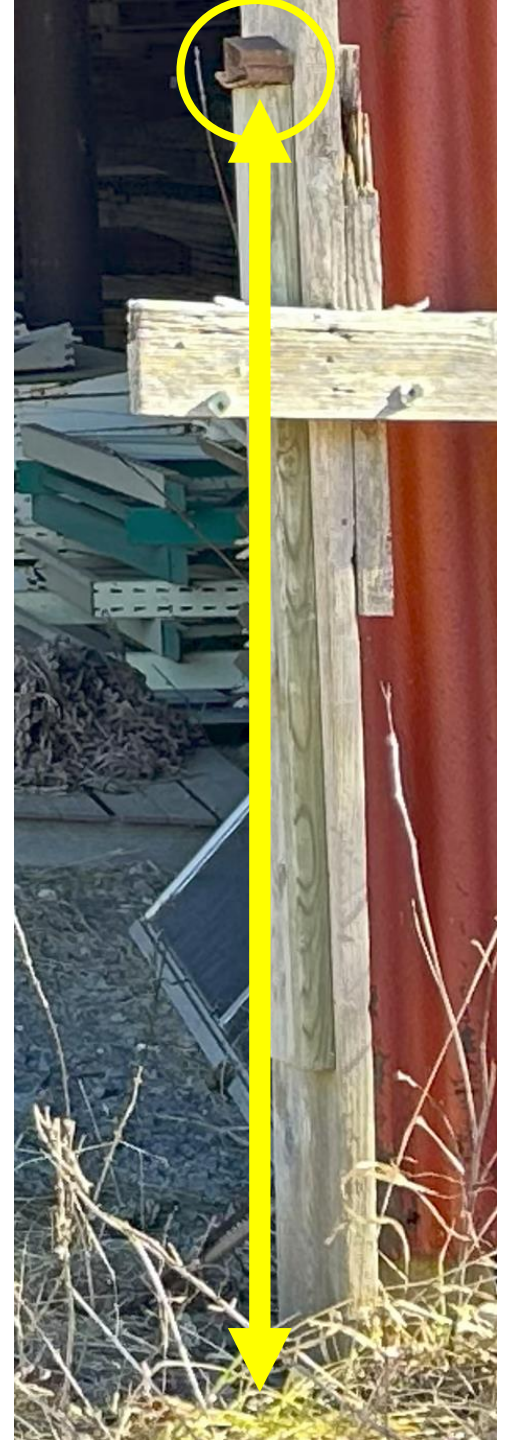
## Old Glades ACE Hardware Sheds

**1996** flood level was described to me by ACE Sales Associate. Damage to boards can be seen from ground level up to appx 53 inches above ground level. See photo. 53 inch height is shown by the piece of metal I placed on the 2x4 in the doorway.
