# FLOOD PROOFING TECHNOLOGY

## *In The Tug Fork Valley*

April 1994

Prepared by:  
**Floodplain Management Services/Special Studies Branch**  
**Planning Division**  
**Huntington District, U.S. Army Corps of Engineers**

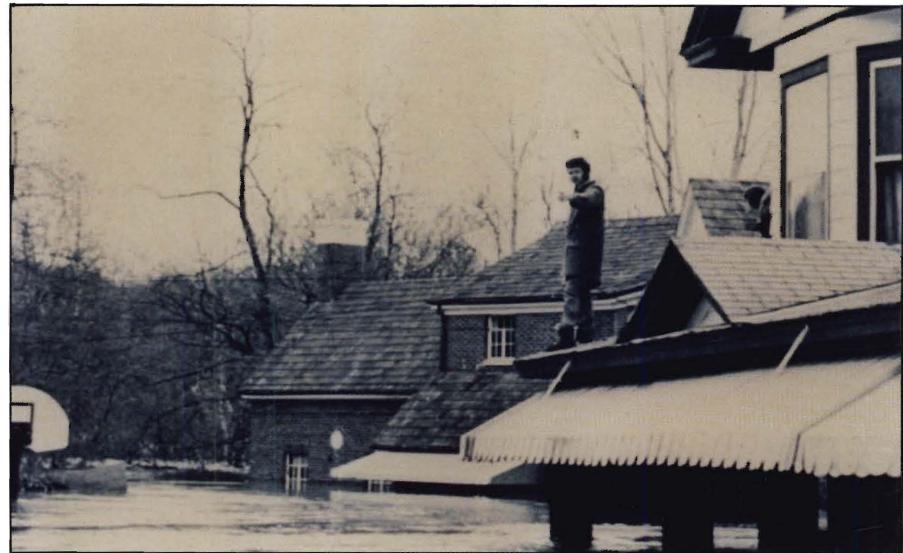
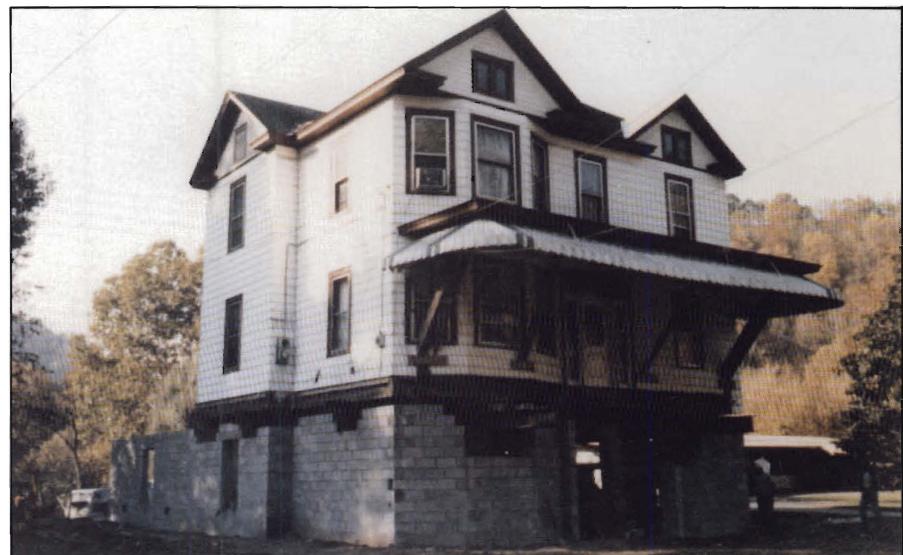
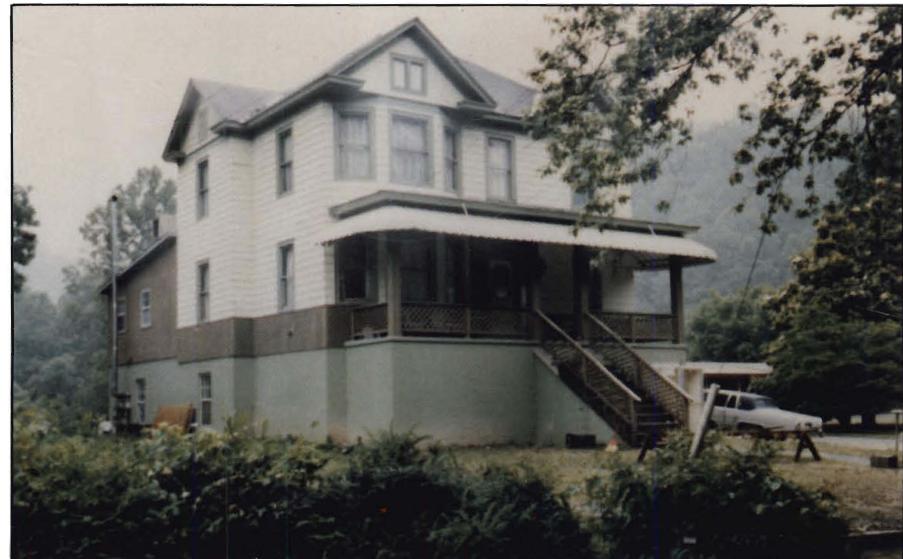
Top: **House on the right during April 1977 flood.**  
Middle: **Same house during flood proofing project.**  
Bottom: **Flood proofing completed.**

*Note: The house was modified by removing the small gable roof above the porch before it was raised.*

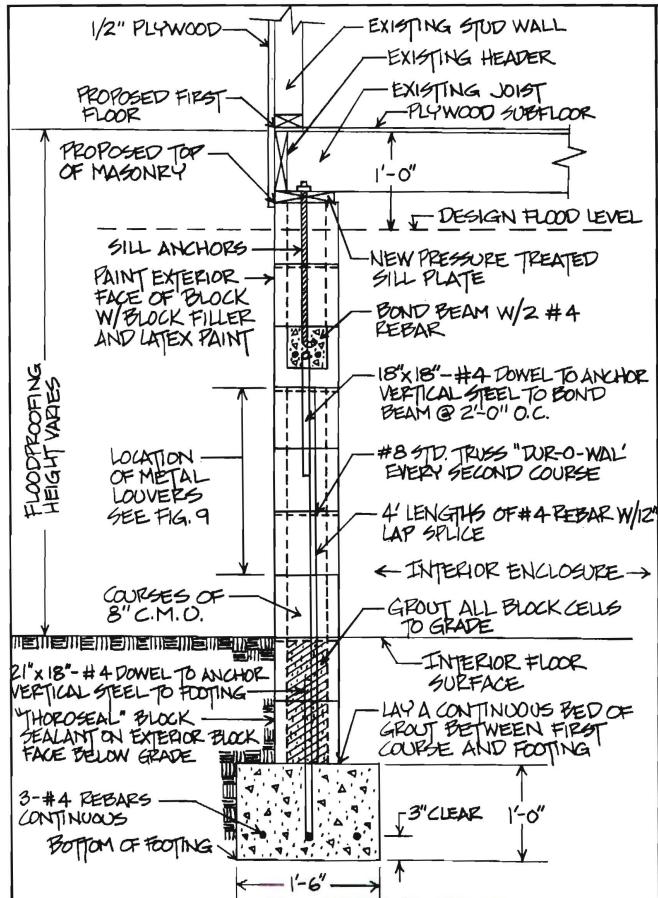
Figure 2.—Typical Wall Section

The basic design of the reinforced masonry wall foundation (*see figure 2*) consisted of a continuous perimeter wall of concrete block (8x8x16 or 8x12x16-inch block) resting upon an appropriately sized (12x18 or 12x24-inch) reinforced concrete footing. The masonry wall contained vertical steel reinforcing grouted into every third cell of the concrete block (*see figure 3*).

The vertical steel was placed in 2 feet lengths with 12-inch lap splicings. All concrete block cells were grouted solid below grade and block sealer was applied to the exterior block face below grade to prevent moisture penetration. The exterior surface of the block was painted with a coating of block filler and two coats of latex paint (owner's choice of colors). The vertical steel was tied to the footing reinforcing and a continuous bond-beam course positioned near the top of the foundation wall. *Figure 4* shows the fourth course below the brick face to be the bond-beam course for this structure. Generally, #4 steel rebar was used in the footing, as vertical reinforcing and in the bond-beam course.

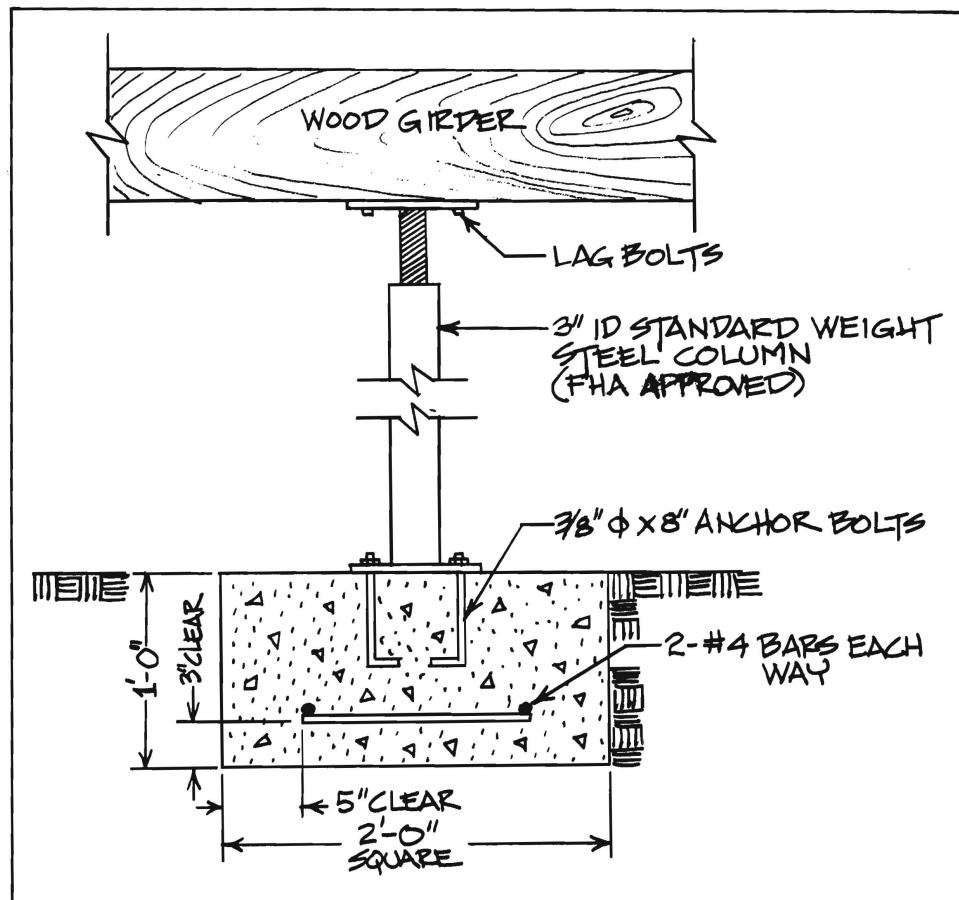
Figure 5.—Interior Column

grade basement, the existing basement wall was removed 2 feet below grade and a new footing was constructed on top of the existing wall before laying the new foundation block. The existing basement floor was fractured and the basement area was filled with compacted free-draining material to the elevation of the exterior grade. Interior supporting masonry or steel pipe columns, when required, were founded on unfractured portions of the existing basement floor or on new footings and extended to the required design height (see figure 5).

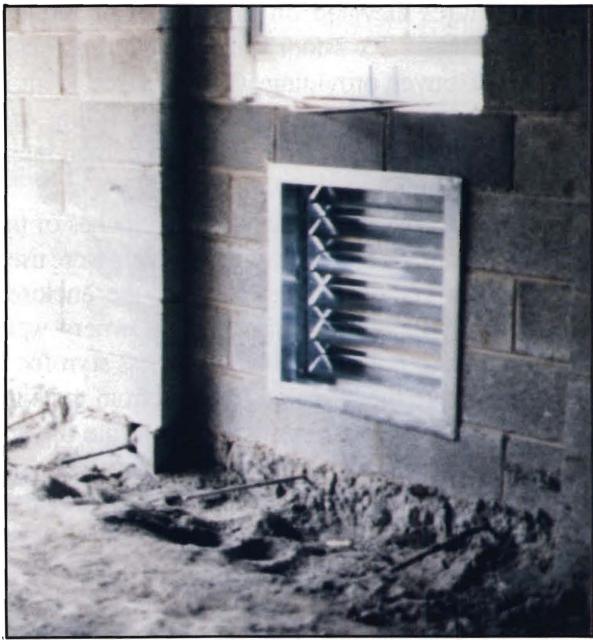
Figure 6.—Flood Louver Inside

In the case of the other foundation designs (wood post/beam and masonry pier) the area beneath the first floor was not entirely enclosed or enclosed with wood lattice, allowing free passage of flood water both into and out of the space without louvers.

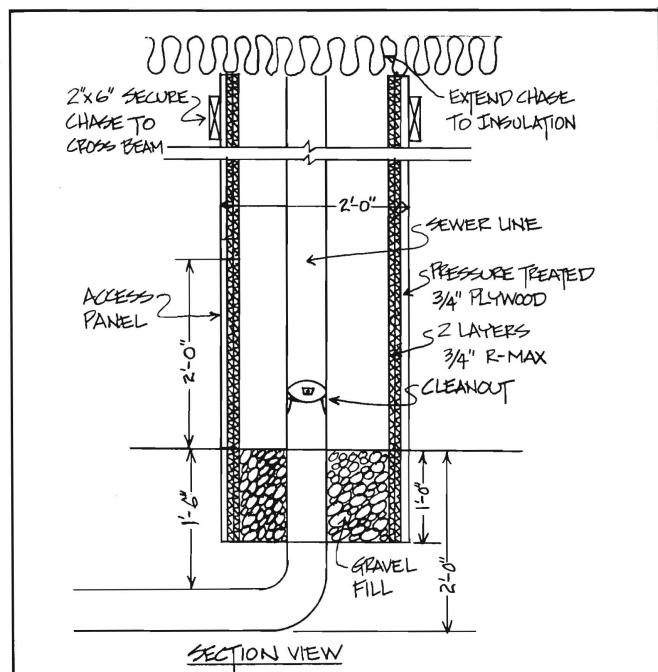
Figure 14.—Pipe Chase Detail Section

Utilities were collected into insulated pipe chases constructed to resist the effects of cold weather (see figures 13 and 14). The structure floor was fully insulated to reduce the increased heating demands caused by unimpeded air flow beneath the structure. The perimeter of the masonry pier foundation was clad with treated wood

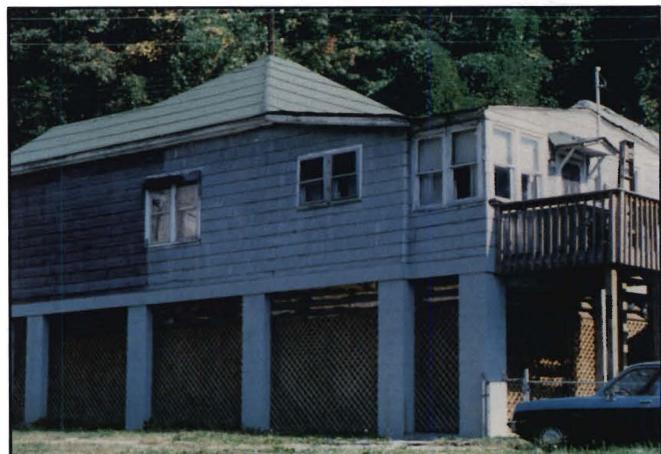
Figure 15.—Wood Lattice Panels

planking and wood lattice to reduce the visual impacts of this design (see figure 15).

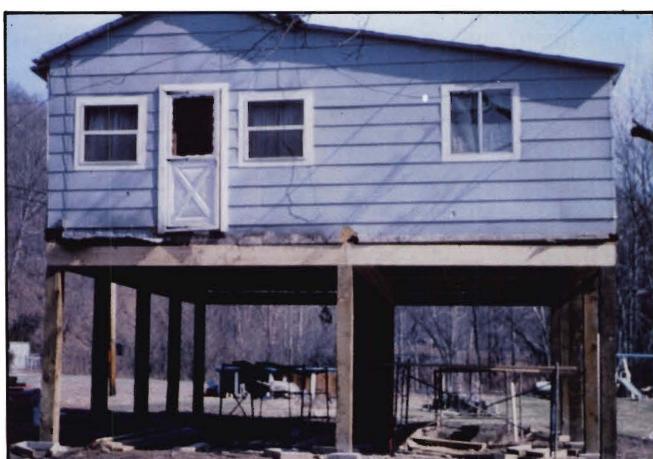
Figure 16.—Wood Post/Beam Post Spacing

The basic design uses 8-inch diameter or square pressure-treated wood posts founded at least 4 feet deep with a continuous 6-inch concrete encasement below grade. Spacing of posts is dependent upon structure size and configuration, size and number of support beams required, soil bearing capacity, and uses of the area below the raised first floor in compliance with local flood plain requirements. *Figure 16* shows the post spacing for a small one-story frame structure being elevated 9 feet.

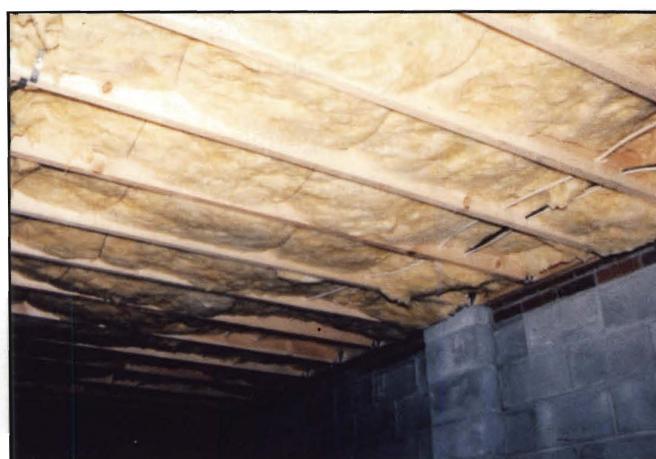
Figure 18.—First Floor Insulation

As in the case of the masonry pier design, it was imperative that the first floor of the home be well insulated

to reduce the increased heating demands caused by the new open "cold space" beneath the structure (see *figure 18*).

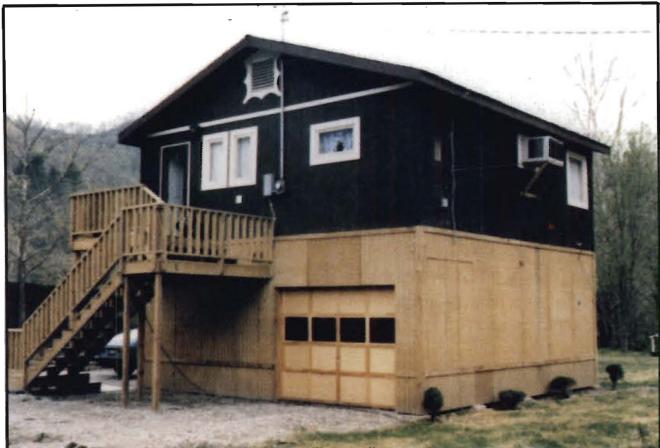
Figure 19.—Wood Post/Beam Hinged Panels

In both cases, the materials used for aesthetic treatment were resistant to water damage and did not impede high water flows. *Figure 19* shows the addition of wood panels to a wood post/beam foundation. The panels were hinged at the top. Break away pins located at the bottom allowed the panels to swing in the direction of the flood flow. This reduced the hydrodynamic loading on the foundation, which reduced obstruction of floodwaters, operation and maintenance costs for the owner, and collection of debris.

to be cost-effective methods for reducing the visual impacts of elevating structures on these types of foundations. In all cases, the lattice and panels were constructed of pressure-treated wood with galvanized metal connectors. Examples of these foundation treatments are shown in *figures 19 and 20*.

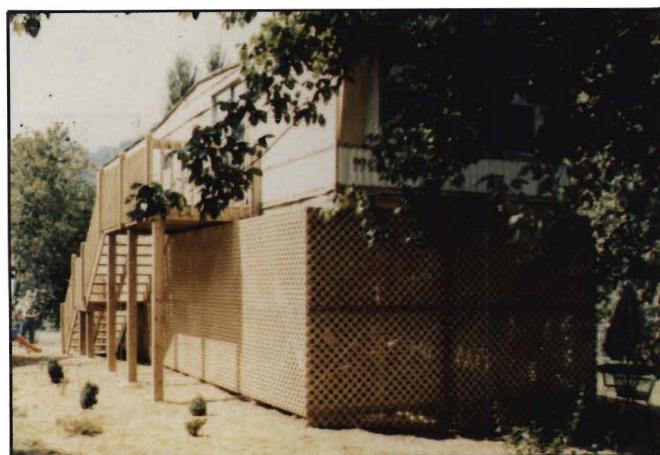
Figure 20.—Wood Post/Beam Lattice Panels

*Figure 20* shows the addition of wood lattice panels to a mobile home with a wood post/beam foundation. The wood post/beam design proved to be effective for use on

mobile homes and smaller wood-frame structures. The design proved not to be useful for masonry or masonry veneer structures. The advantages of this design included reduced impedance of flood flows around the structure, and reduced costs compared to the solid masonry wall design. The disadvantages of the design include increased costs for insulation of floors and utilities, reduced security of the new foundation area, limited application to a variety of architectural styles, increased O&M costs, and increased costs for aesthetic treatment.

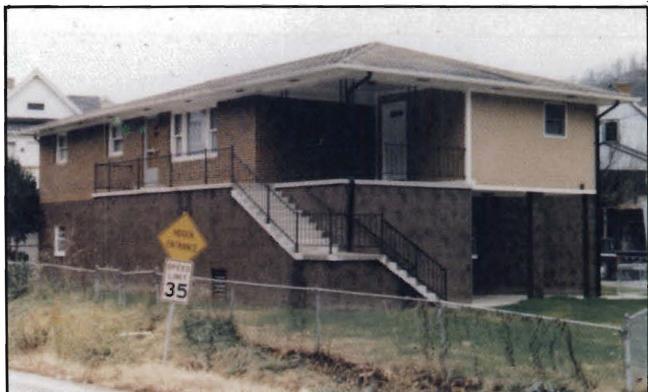
Figure 21.—Visual Aesthetics Painted Finish

Figures 21, 22, and 23 show a selection of the foundation treatments used for solid masonry walls in the program. In addition to painting the wall surfaces, the addition of access doors, garage doors, and windows in the solid masonry wall design shown in figures 24 and 25 significantly improved the look of the elevated structure.

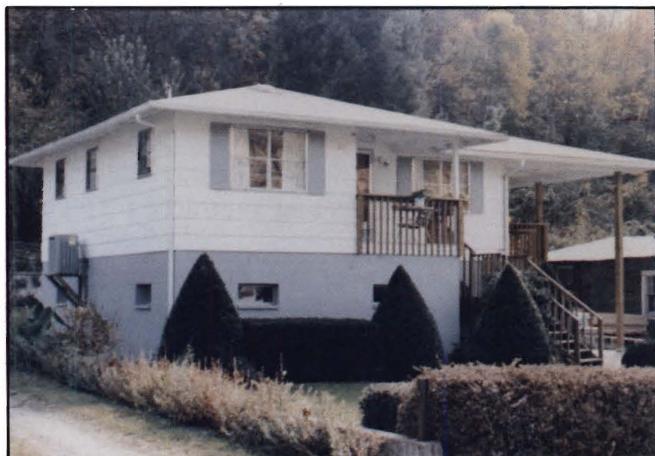
Figure 26.—Visual Aesthetics/Landscape Plantings

In addition to the aesthetic foundation treatments mentioned above, landscape plantings used to screen the new foundation system proved to be a cost-effective solution in several areas. *Figure 26* shows one instance where the use of landscape plantings was effective in screening the new foundation.

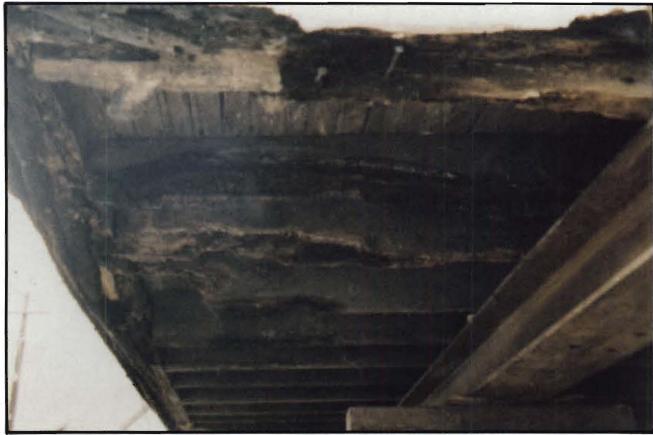
Figure 27.—Structure Damage Deteriorated Floors

In most structures, the sill plates, header boards, and many of the joists and beams had been severely deteriorated by repeated flooding and were replaced with pressure-treated wood during elevation of the structure. *Figure 27* shows a situation where the existing deteriorated floor system was replaced to allow safe elevation of the structure. The replacement of floor systems was limited to

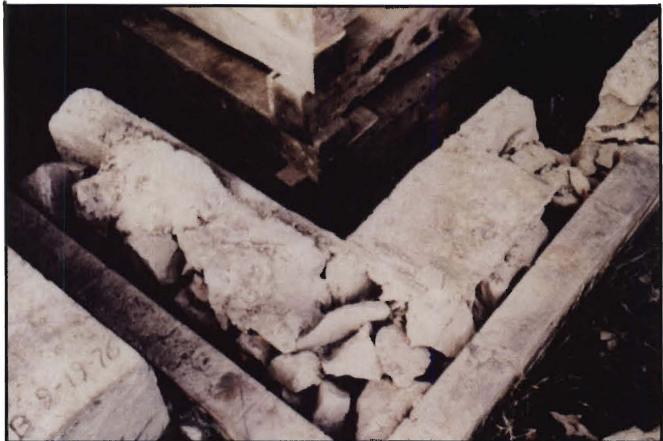
Figure 28.—Structure Damage Deteriorated Foundation

The foundation systems of most of the eligible structures were in very poor condition due to age and repeated flooding as shown in *figure 28*. Concrete and mortar in footings, masonry foundation walls, interior columns and chimney supports were deteriorated to such an extent that use as a base for new construction was impossible. Most existing footings were removed due to deterioration from flooding and were replaced during construction of the new foundation.

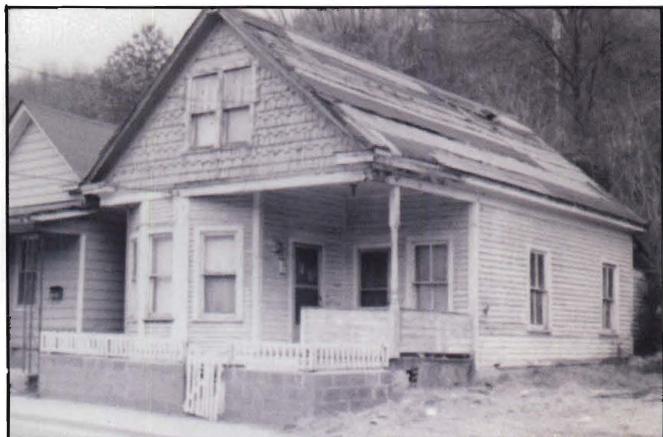
Figure 29.—Structure Damage From Age And Flooding

*Figure 29* is an example of a structure used to show the combination of damages which were so severe that the structure was acquired in lieu of flood proofing.

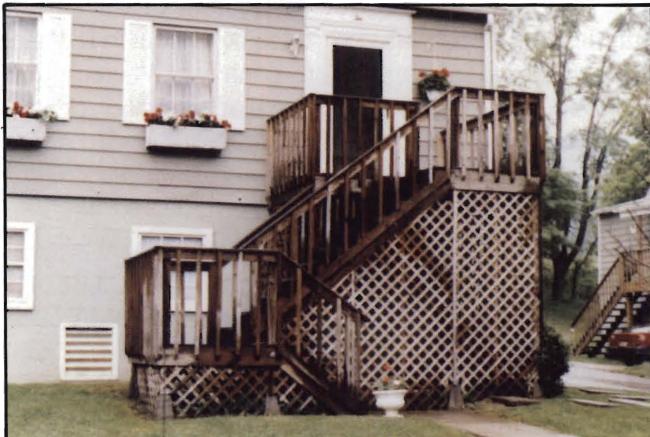
Figure 30.—Access By Pressure-Treated Decks And Steps

Generally, residential access was accomplished by construction of pressure-treated wood decks and steps connected to existing walkways and driveways (see *figure 30*).

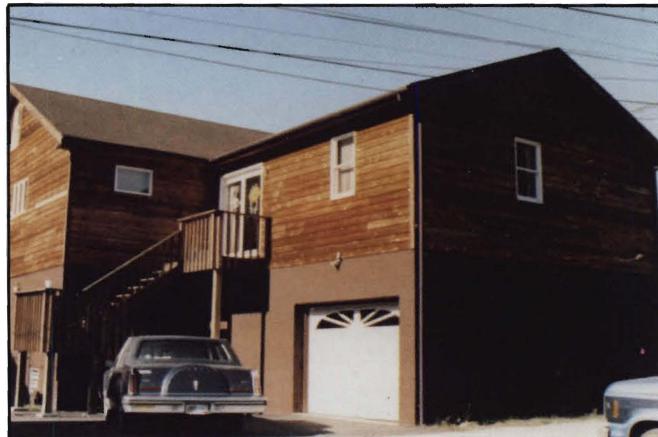
Figure 33.—Garage Added On First Floor

In those cases where the existing structure had an attached garage and the structure was being elevated at least 8 feet, the garage entrance was replaced in the solid masonry wall foundation (*see figure 33*).

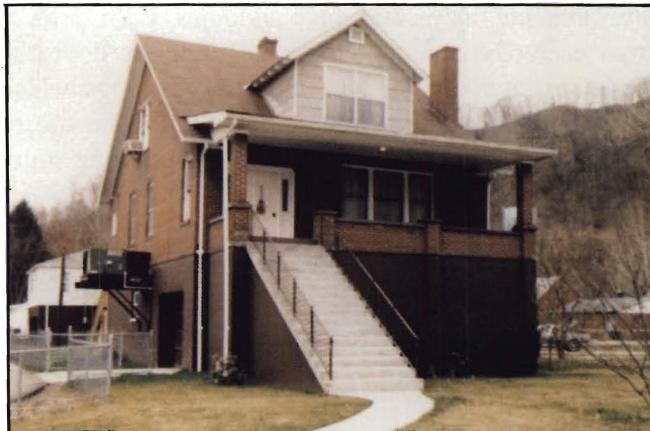
Figure 31.—Masonry Porch Raised With Steps

In some cases, an existing masonry porch was physically attached to the structure in a manner which required lifting the porch with the structure and construction of a new foundation under the raised porch (see *figure 31*).

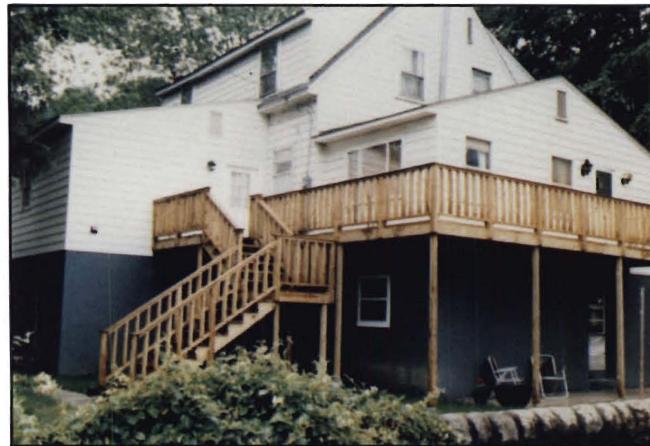
Figure 32.—Central Stairway Multiple Entrances

For structures with multiple first floor entrances, engineering analyses determined that connection of the entrances with elevated walkways leading to a central stairway was more cost-effective than multiple stairways (see *figure 32*).

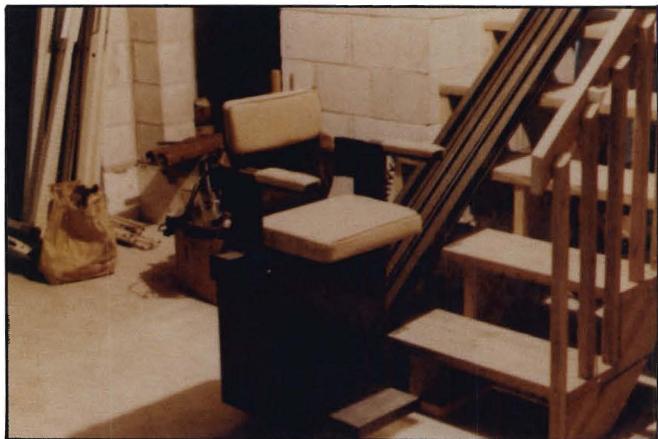
Figure 35.—Handicapped Access By Interior Chairlift

Where ramps were not technically feasible, a mechanical chair lift was installed to provide handicapped access. The lifts were normally installed on the interior access stairway, (*see figure 35*) to reduce the exposure of the lift system to the weather, but some systems were installed on an exterior stairway (*see figure 36*).

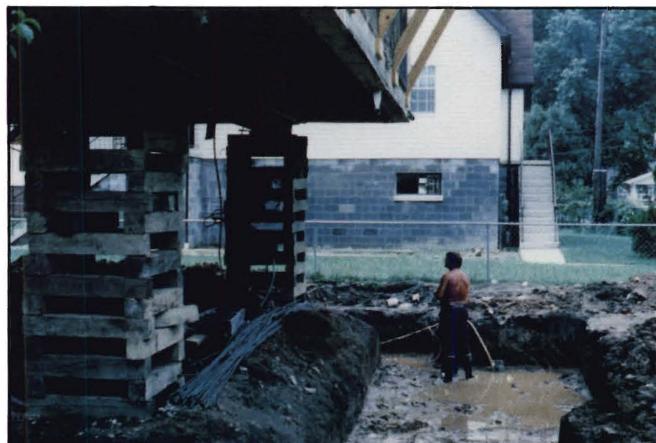
Figure 38.—Placement Of Cribbing Supports

In one case, failure of a cribbing base located adjacent to a footing excavation nearly resulted in the collapse of an elevated structure. This event led to excavation of all cribbing bases in order to avoid the consequences of bank failure (see figure 38).

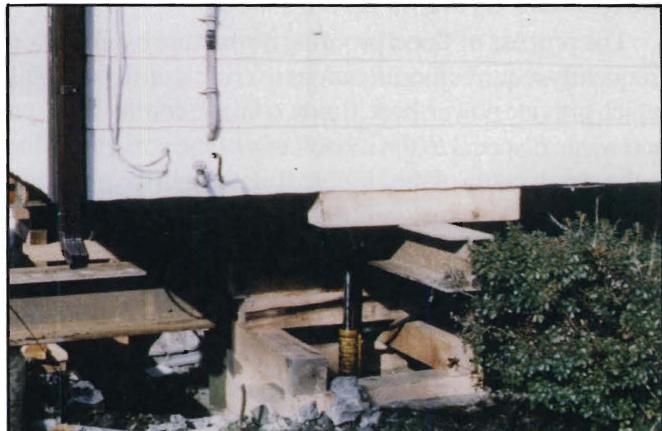
Figure 39.—Placement Of Hydraulic Jacks

These areas required placement of cribbing supports or additional steel beam supports. Critical areas in commercial structures included heavy equipment rooms, interior supporting walls, storage and stock areas, and concrete slab floors. Also required in the lifting plan was the proposed lifting system. Most lifting contractors used a unified hydraulic jacking system which allowed collective or individual control of hydraulic jacks located within the cribbing supports (*see figure 39*).

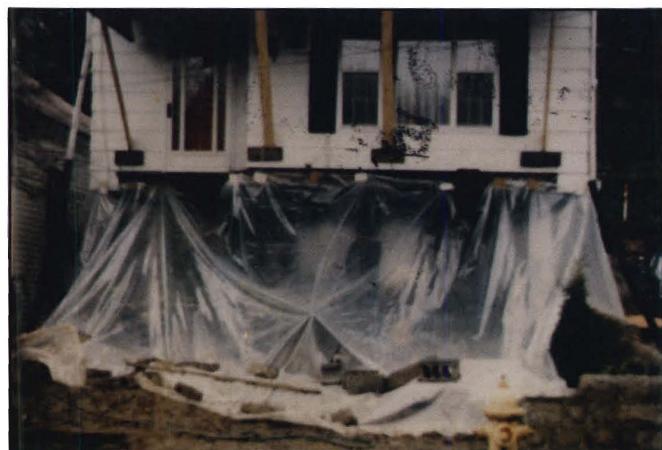
Figure 41.—Weather Protection Plastic Skirting

Weather related problems were solved, in part, by installing plastic skirting around the bottom of the raised structure, as shown in *figure 41*. Once the plastic skirting was installed, the area beneath the structure was protected from precipitation and could be heated to a temperature that protected utilities and allowed concrete and mortar work to proceed.

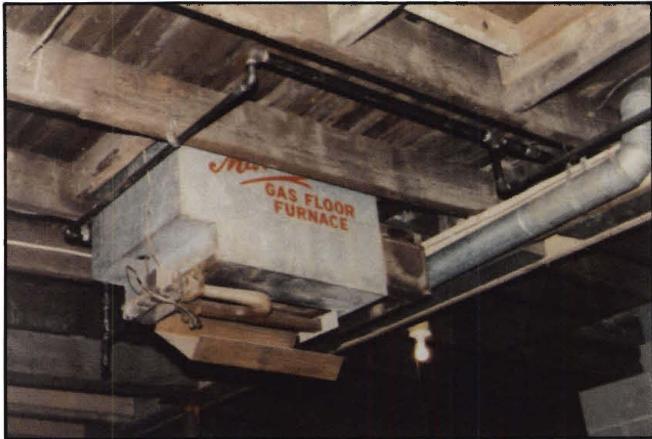
Figure 42.—Heating Unit Raised With Structure

The process of flood proofing a structure by elevation frequently requires modifications to critical utility systems which provide power, heat, fluids, coolant, communication and waste disposal to the inhabitants of the structure. Due to the age of many of the eligible structures in the program, the existing heating, ventilation, and air conditioning (HVAC) systems were antiquated and in many cases were difficult to raise with the structure. Many homes in the project area were heated by up-flow gas-fired floor furnaces, which under program criteria and local ordinances were needed to be raised above the design flood height (*see figure 42*).

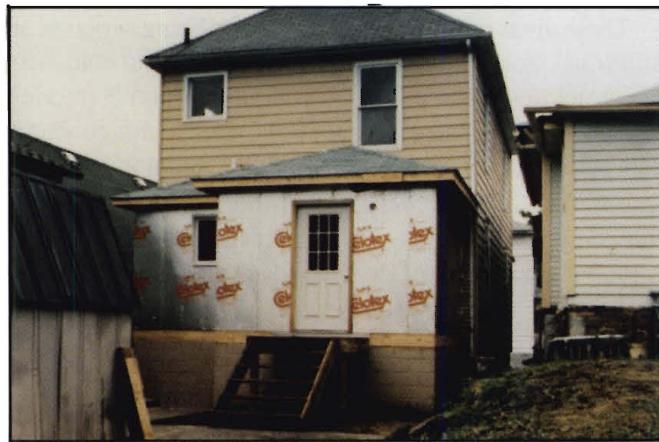
Figure 43.—Elevated Utility Room

Generally, other types of HVAC systems such as hot-water, forced-air, and heat pumps and their various component parts were raised by relocation into existing available spaces such as closets or utility rooms within the first floor, relocation into a new utility room raised to the same elevation as the structure (*see figure 43*) or relocation onto an elevated exterior platform (*see figures 44 and 45*).

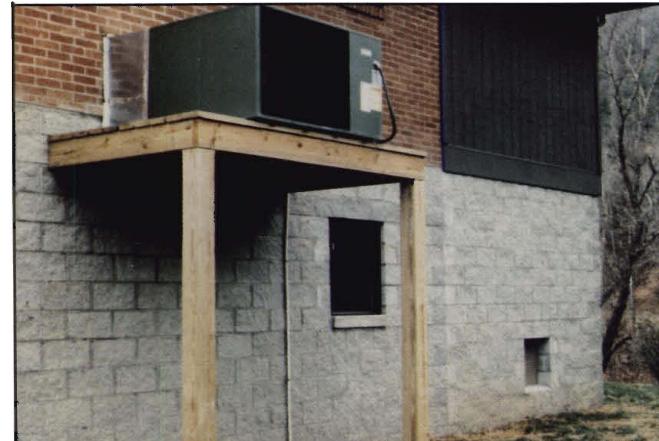
Figure 45.—Compressor Unit On Elevated Platform

An exterior air-conditioning unit was relocated onto a raised pressure-treated wood platform (see figure 45). A

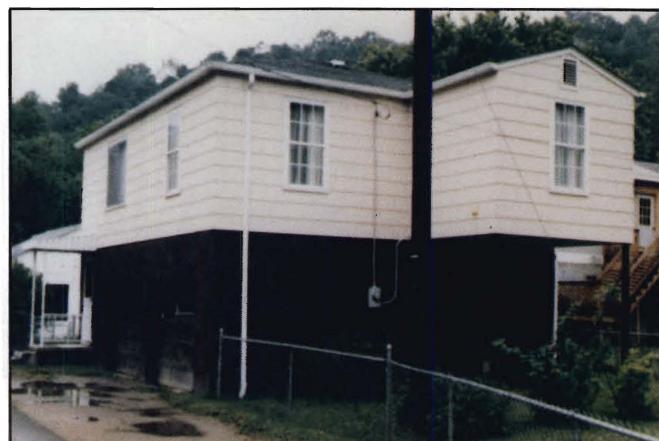
Figure 47.—Converted Garage Elevated

Many of the structures in the project area were constructed with attached garages and chimneys. The nonstructural program criteria excluded detached garages, outbuildings and storage buildings from the flood proofing program. Only garages or out-buildings that had been converted to living space were eligible for the flood proofing program under Section 202, Public Law 96-367 (*see figure 47*).

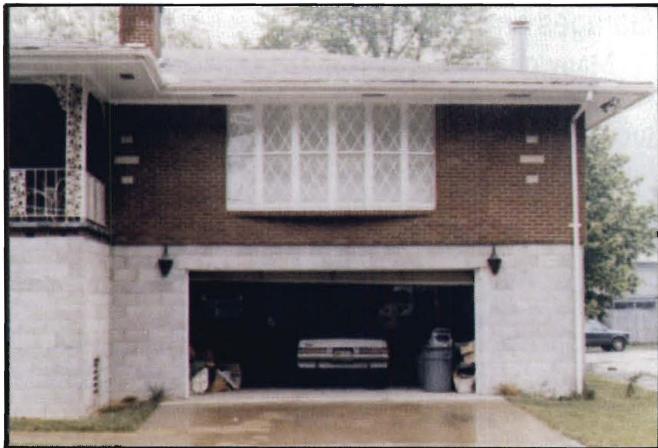
Figure 48.—Garage Converted To Living Space

proximity to the existing garage structure. In those cases where replacement space was required or when flood-prone mechanical systems or utilities were elevated with the residence, the attached garage was separated from its concrete slab floor and elevated with the residence and the interior garage space was enclosed. The garage door opening was closed, a bay window installed, and a new floor was constructed converting the area to living space (*see figure 48*).

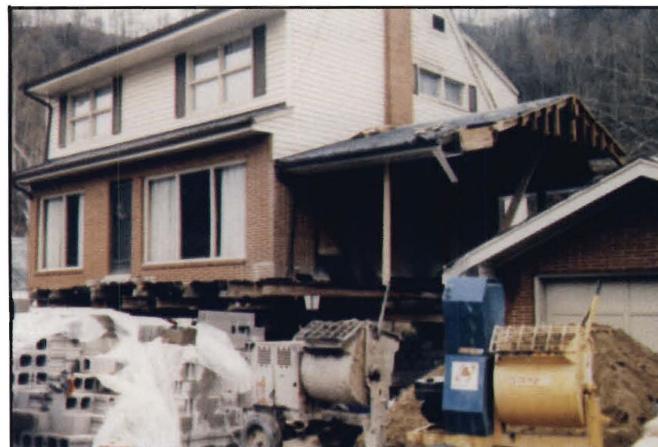
Figure 50.—Garage Separated Before House Elevation

In all cases, this approach was determined to be more cost-effective than the construction of a new elevated addition for these uses and preserved the architectural quality of the structure by not separating the roofline. Structure owners were responsible for interior finishing beyond basic wallboard, paint and plywood subfloor. A floor slab and garage door opening were provided in the new foundation for replacement of the elevated garage area (*see figure 49*). In several cases, the attached garage was separated from the residence prior to raising and was left at the original elevation (*see figure 50*).

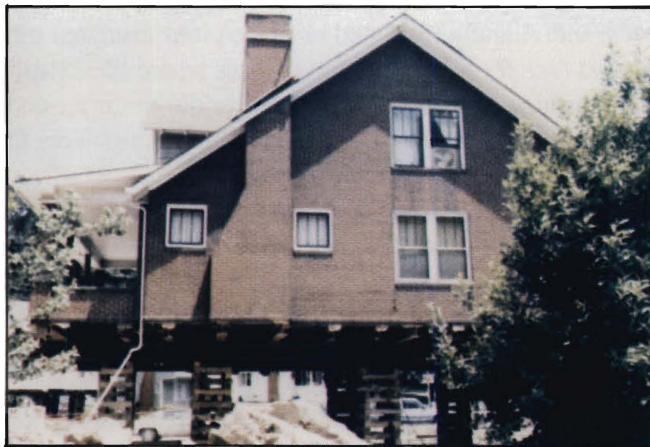
Figure 51.—Chimney Elevated With Structure

raised with the structure by bracing the base and, if necessary, the top of the chimney. A new masonry wall foundation was constructed under the chimney (*see figure 51*).

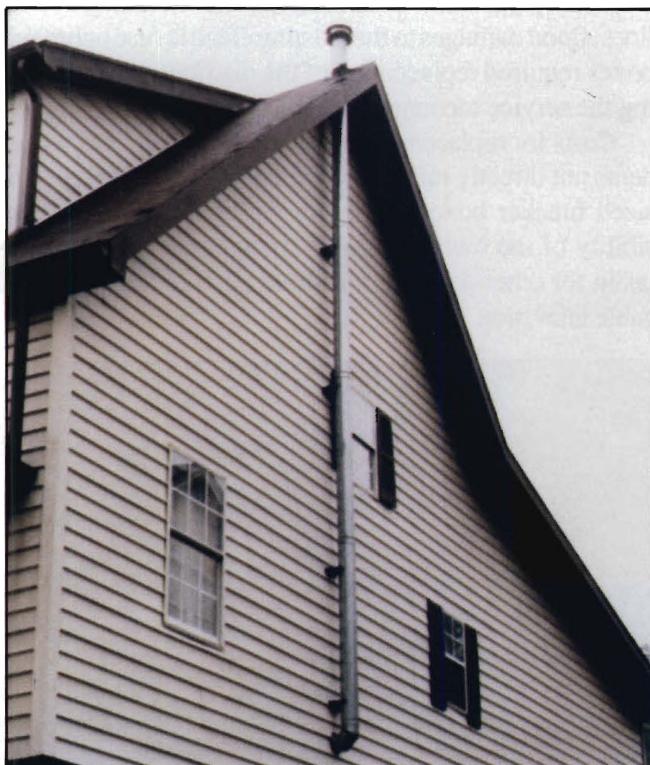
Figure 52.—Chimney Replaced With Metal Flue

Several unstable, but operational chimneys were replaced with cost-effective metal flue systems (*see figure 52*). Replacement of existing chimneys with metal flue systems was standard practice in masonry pier and wood post/beam foundations. In cases where the existing chimney(s) were not operational, they were removed during flood proofing construction, and not replaced.

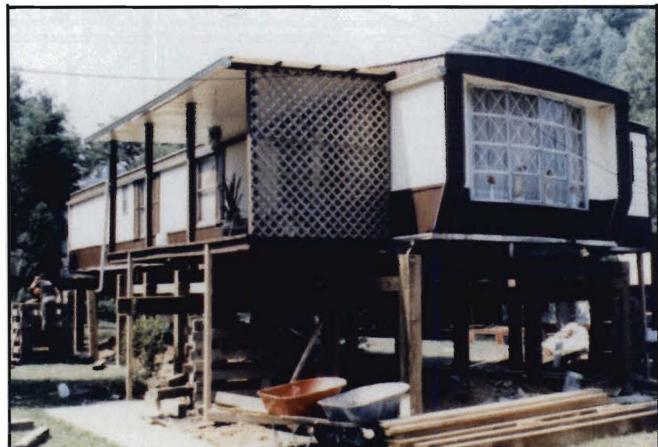
Figure 56.—Deck Raised With Manufactured Unit

Access to the raised unit was accomplished by pressure-treated wood steps and decks. In cases where manufactured units had existing decks, those decks were raised with the structure (see figure 56). Where handicapped access was required, mechanical chair lifts were installed on the exterior access steps. The placement of existing and new decks provided platforms for raised mechanical HVAC systems and electric meters. In other cases the mechanical HVAC system was raised on a separate platform adjacent to the manufactured unit.

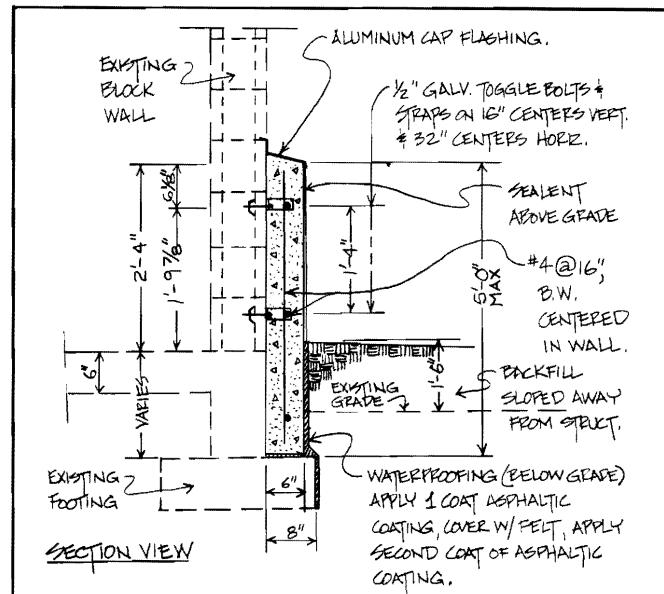
Figure 57.—Veneer Wall Detail Section

The veneer wall was constructed of reinforced poured concrete. The wall was six inches thick and extended from the existing footing to an elevation one foot above the design flood (see figure 57). The wall was attached to the existing masonry wall with metal anchors (see figure 58) and formed rubber waterstops were installed between all concrete joints. Aluminum flashing was installed along the top of the wall to prevent rainwater from seeping

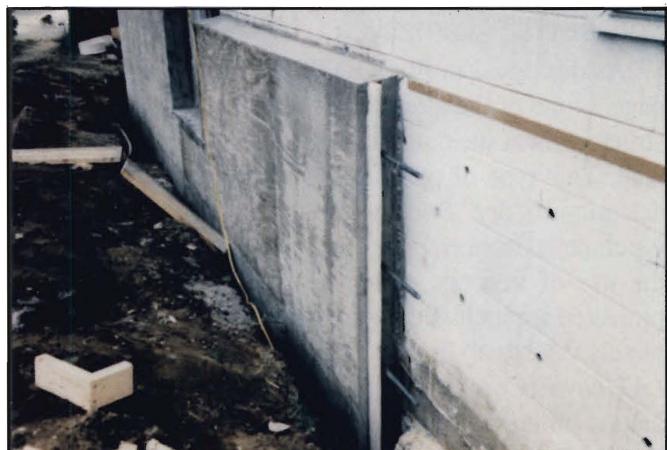
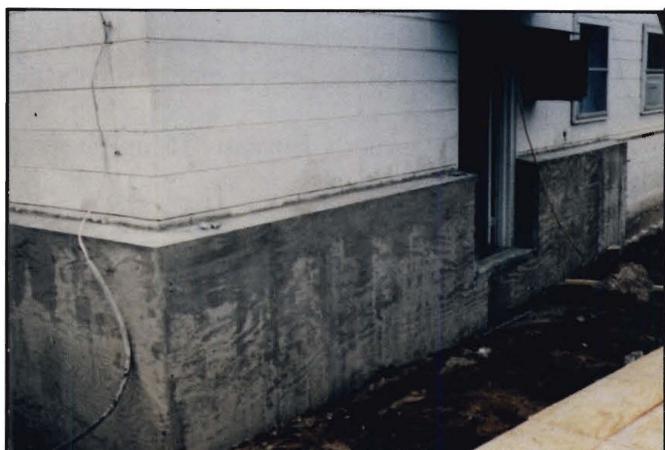
Figure 61.—Veneer Wall Construction Views

Detailed instructions regarding the operation and maintenance of the veneer wall, closure and utility valve were placed on wall placards both on the exterior wall next to the closure and inside the church. These items were included in the agreement executed between the church owners and the Corps of Engineers. *Figures 61 and 62* show the veneer wall during construction.

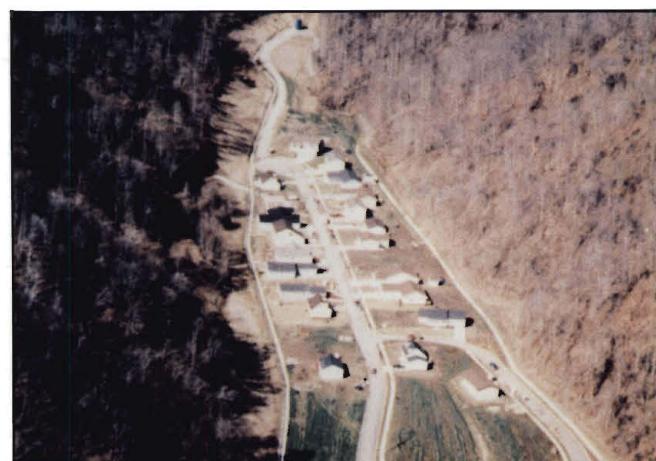
Figure 64.—Valley View Housing Site

The Valley View H&CD site, which contains 56 single-family housing sites, is located adjacent to the incorporated limits of Williamson, West Virginia, where the majority of flood plain relocations are occurring (*see figure 1*). This location will facilitate the annexation of the site by the city of Williamson and recovery of a portion of the relocated tax base. Upon completion of the site construction in 1989, the West Virginia Housing Development Fund, acting as the local sponsor and under contract to the Corps of Engineers, initiated the construction of comparable replacement residences for eligible flood plain parties at the Valley View site. The Valley View H&CD site is shown in *figure 64*. The Pond Creek H&CD site which was designed

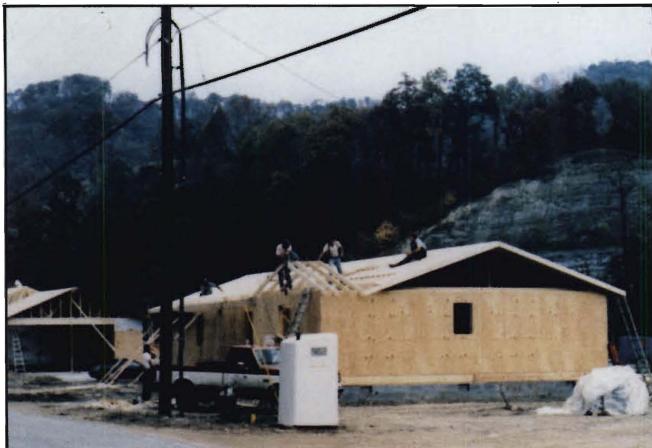
Figure 65.—Pond Creek Housing Site

to accommodate 21 single-family lots is located in the unincorporated South Williamson, Kentucky, area (*see figure 1*). Site construction was completed in 1991 and the construction of comparable replacement residences is being administered by the Kentucky Housing Corporation under contract to the Corps of Engineers. Construction of replacement homes at this site for flood plain relocated parties in the South Williamson project area was completed in 1992 (*see figure 65*).

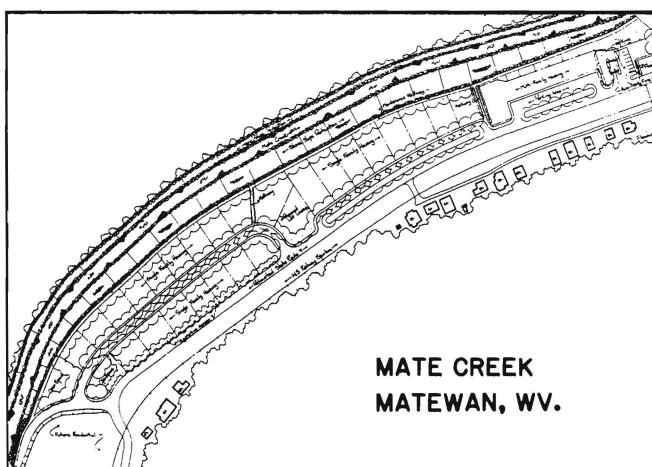
Figure 66.—Mate Creek Housing Site

The Mate Creek site is located in Matewan, West Virginia, and is scheduled for completion in 1995 in conjunction with the Matewan, West Virginia, Local Protection Project. This project is a structural component of the Section 202 program. The construction of 26 single-family and 16 multifamily units in the Mate Creek housing site is expected to be completed in 1996 in cooperation with the West Virginia Housing Development Fund (*see figure 66*).

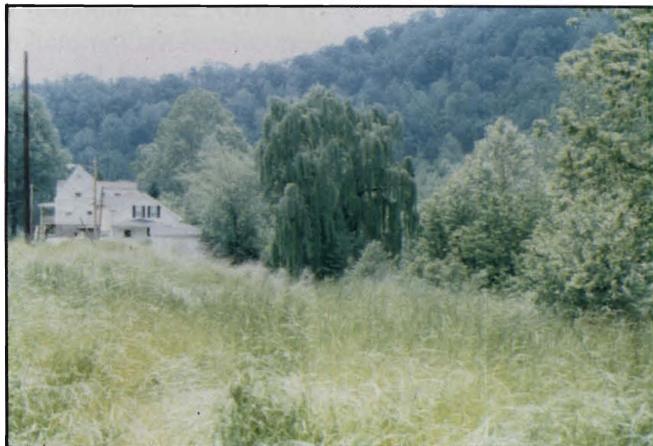
Figure 67.—Evacuated Tracts For Mitigation

acquisition planning between the Corps of Engineers and coordinating state natural resources agencies identified those flood plain tracts which would be most suitable for replacement mitigation habitat (*see figure 67*).

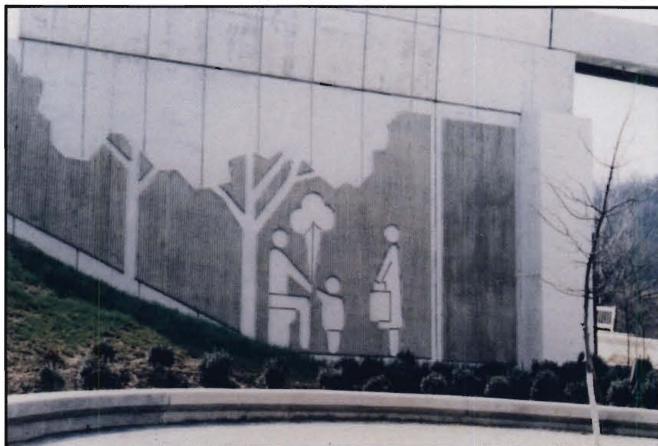
Figure 69.—Floodwall Graphics

(*see figure 69*).

Care was taken in locating graphics to assure that views into and from the floodwall graphics did not conflict with existing or proposed cultural or environmental features adjacent to the floodwall.

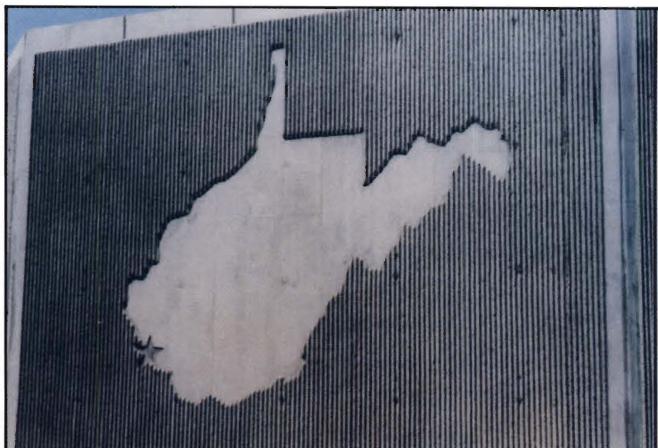
Figure 70.—Vertical Fractured-Fin Design

The pattern used as a background texture on the floodwalls is a vertical fractured-fin design (*see figure 70*). A smooth finish is maintained around the edges of each textured panel to provide a picture frame effect and to facilitate tight closures at the form edges between monolith concrete pours. To accentuate this pattern the floodwall was designed without coping.

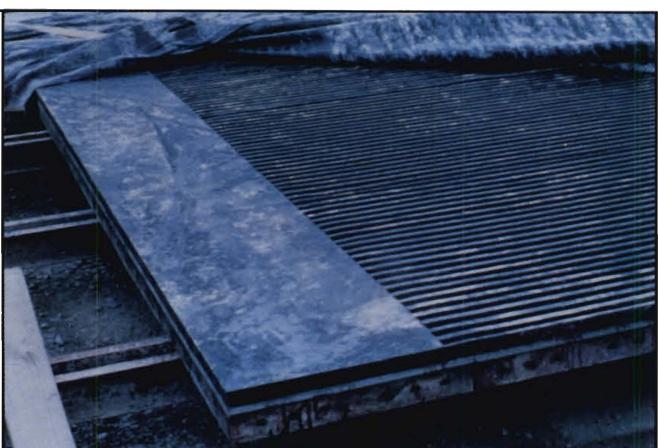
Figure 71.—Graphic Form Liners

The polyurethane elastomeric form liners (fractured fin-pattern) were prepared with plywood backing (*see figure 71*).

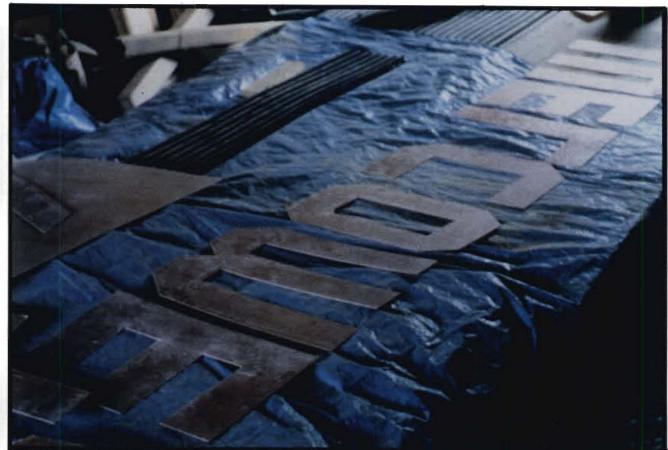
Figure 72.—Graphic Patterns

The graphic patterns, cut from plywood or particle board, were nailed to the surface of the form liner in reversed, negative position (*see figure 72*) and the voids behind the graphic panels were filled in with styrofoam to prevent concrete leakage into the graphics.

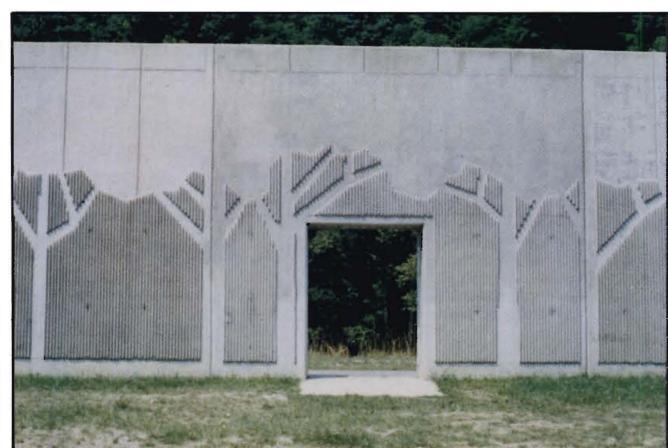
Figure 73.—Sack-Rubbed Finish On Graphics

The entire graphic assembly was tied to the steel floodwall forms. Tie rods were carefully positioned to avoid conflicts with the graphics and the fractured-fin texture. The panels were filled with concrete and allowed to set. The forms were removed from the wall surface and the graphic surfaces and framed edges of the monoliths were sack-rubbed with white cement to fill voids and further accentuate the graphics (*see figure 73*).
