Subject: RAMPP West Virginia LiDAR QA/QC: Tug Watershed Delivery

RAMPP has been tasked and funded by FEMA Region III to perform LiDAR quality assurance and quality control checks for a 3,165km² portion of southern West Virginia. The evaluation will assess the usability of the LiDAR data in supporting the West Virginia Department of Environmental Protection Division of Mining and Reclamation. In addition, the report will comment on the LiDAR's adherence to FEMA's "Procedure Memorandum No. 61 – Standards for LiDAR and Other High Quality Digital Topography." The delivery includes 1,368 LAS tiles. The dataset is referred to as the Tug Watershed delivery.

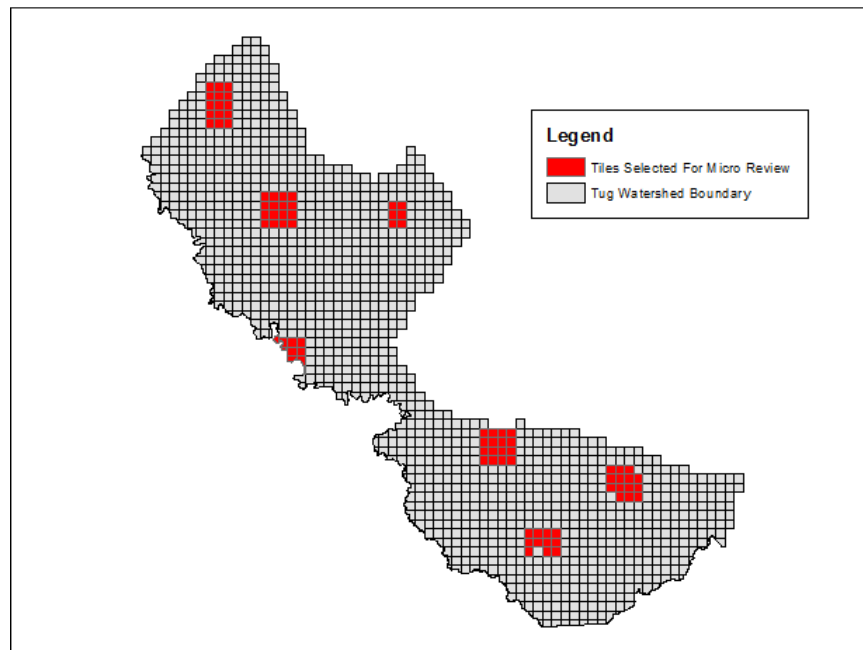
Figure 3: Tiles selected for the micro review

According to the RAMPP Statement of Work, a 5% micro-level visual review was conducted on the LiDAR data to identify qualitative errors in the dataset. A total of 88 tiles were selected for the review. Many of these errors are easily fixed, such as vegetation artifacts and aggressive classification. Some of the errors require further review, such as the tile-wide elevation offset.
