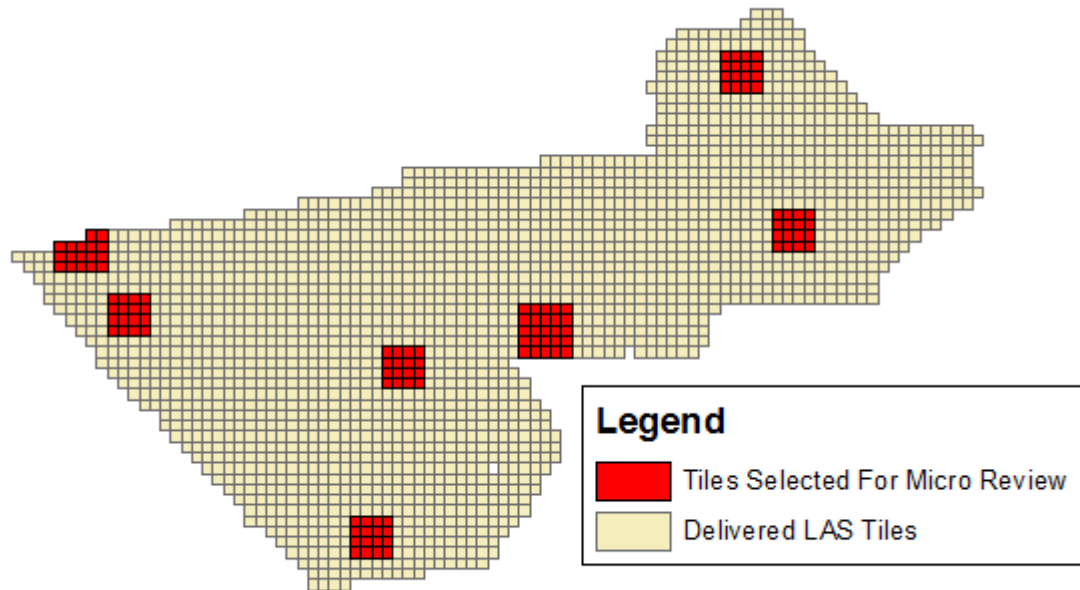
Figure 3 - Tiles selected for the micro review

The table below shows the breakdown of the call types:

Table 1 - Breakdown of edit calls made in the 5% visual review of the Third Delivery LAS.

Call Type	Number of Occurrences
Aggressive Misclassification	81
Artifact	200
Divot	8
Culvert Misclassification	12
Tile Overlap Effect	104
Total	405
