**FINAL REPORT ON LANDSLIDES  
OF JULY 9, 1973  
IN KANAWHA CITY AREA  
OF CHARLESTON, WEST VIRGINIA**

**Ronald A. Landers  
and  
Richard A. Smosna**

**WEST VIRGINIA GEOLOGICAL AND ECONOMIC SURVEY  
ROBERT B. ERWIN, DIRECTOR AND STATE GEOLOGIST**

**September 7, 1973**

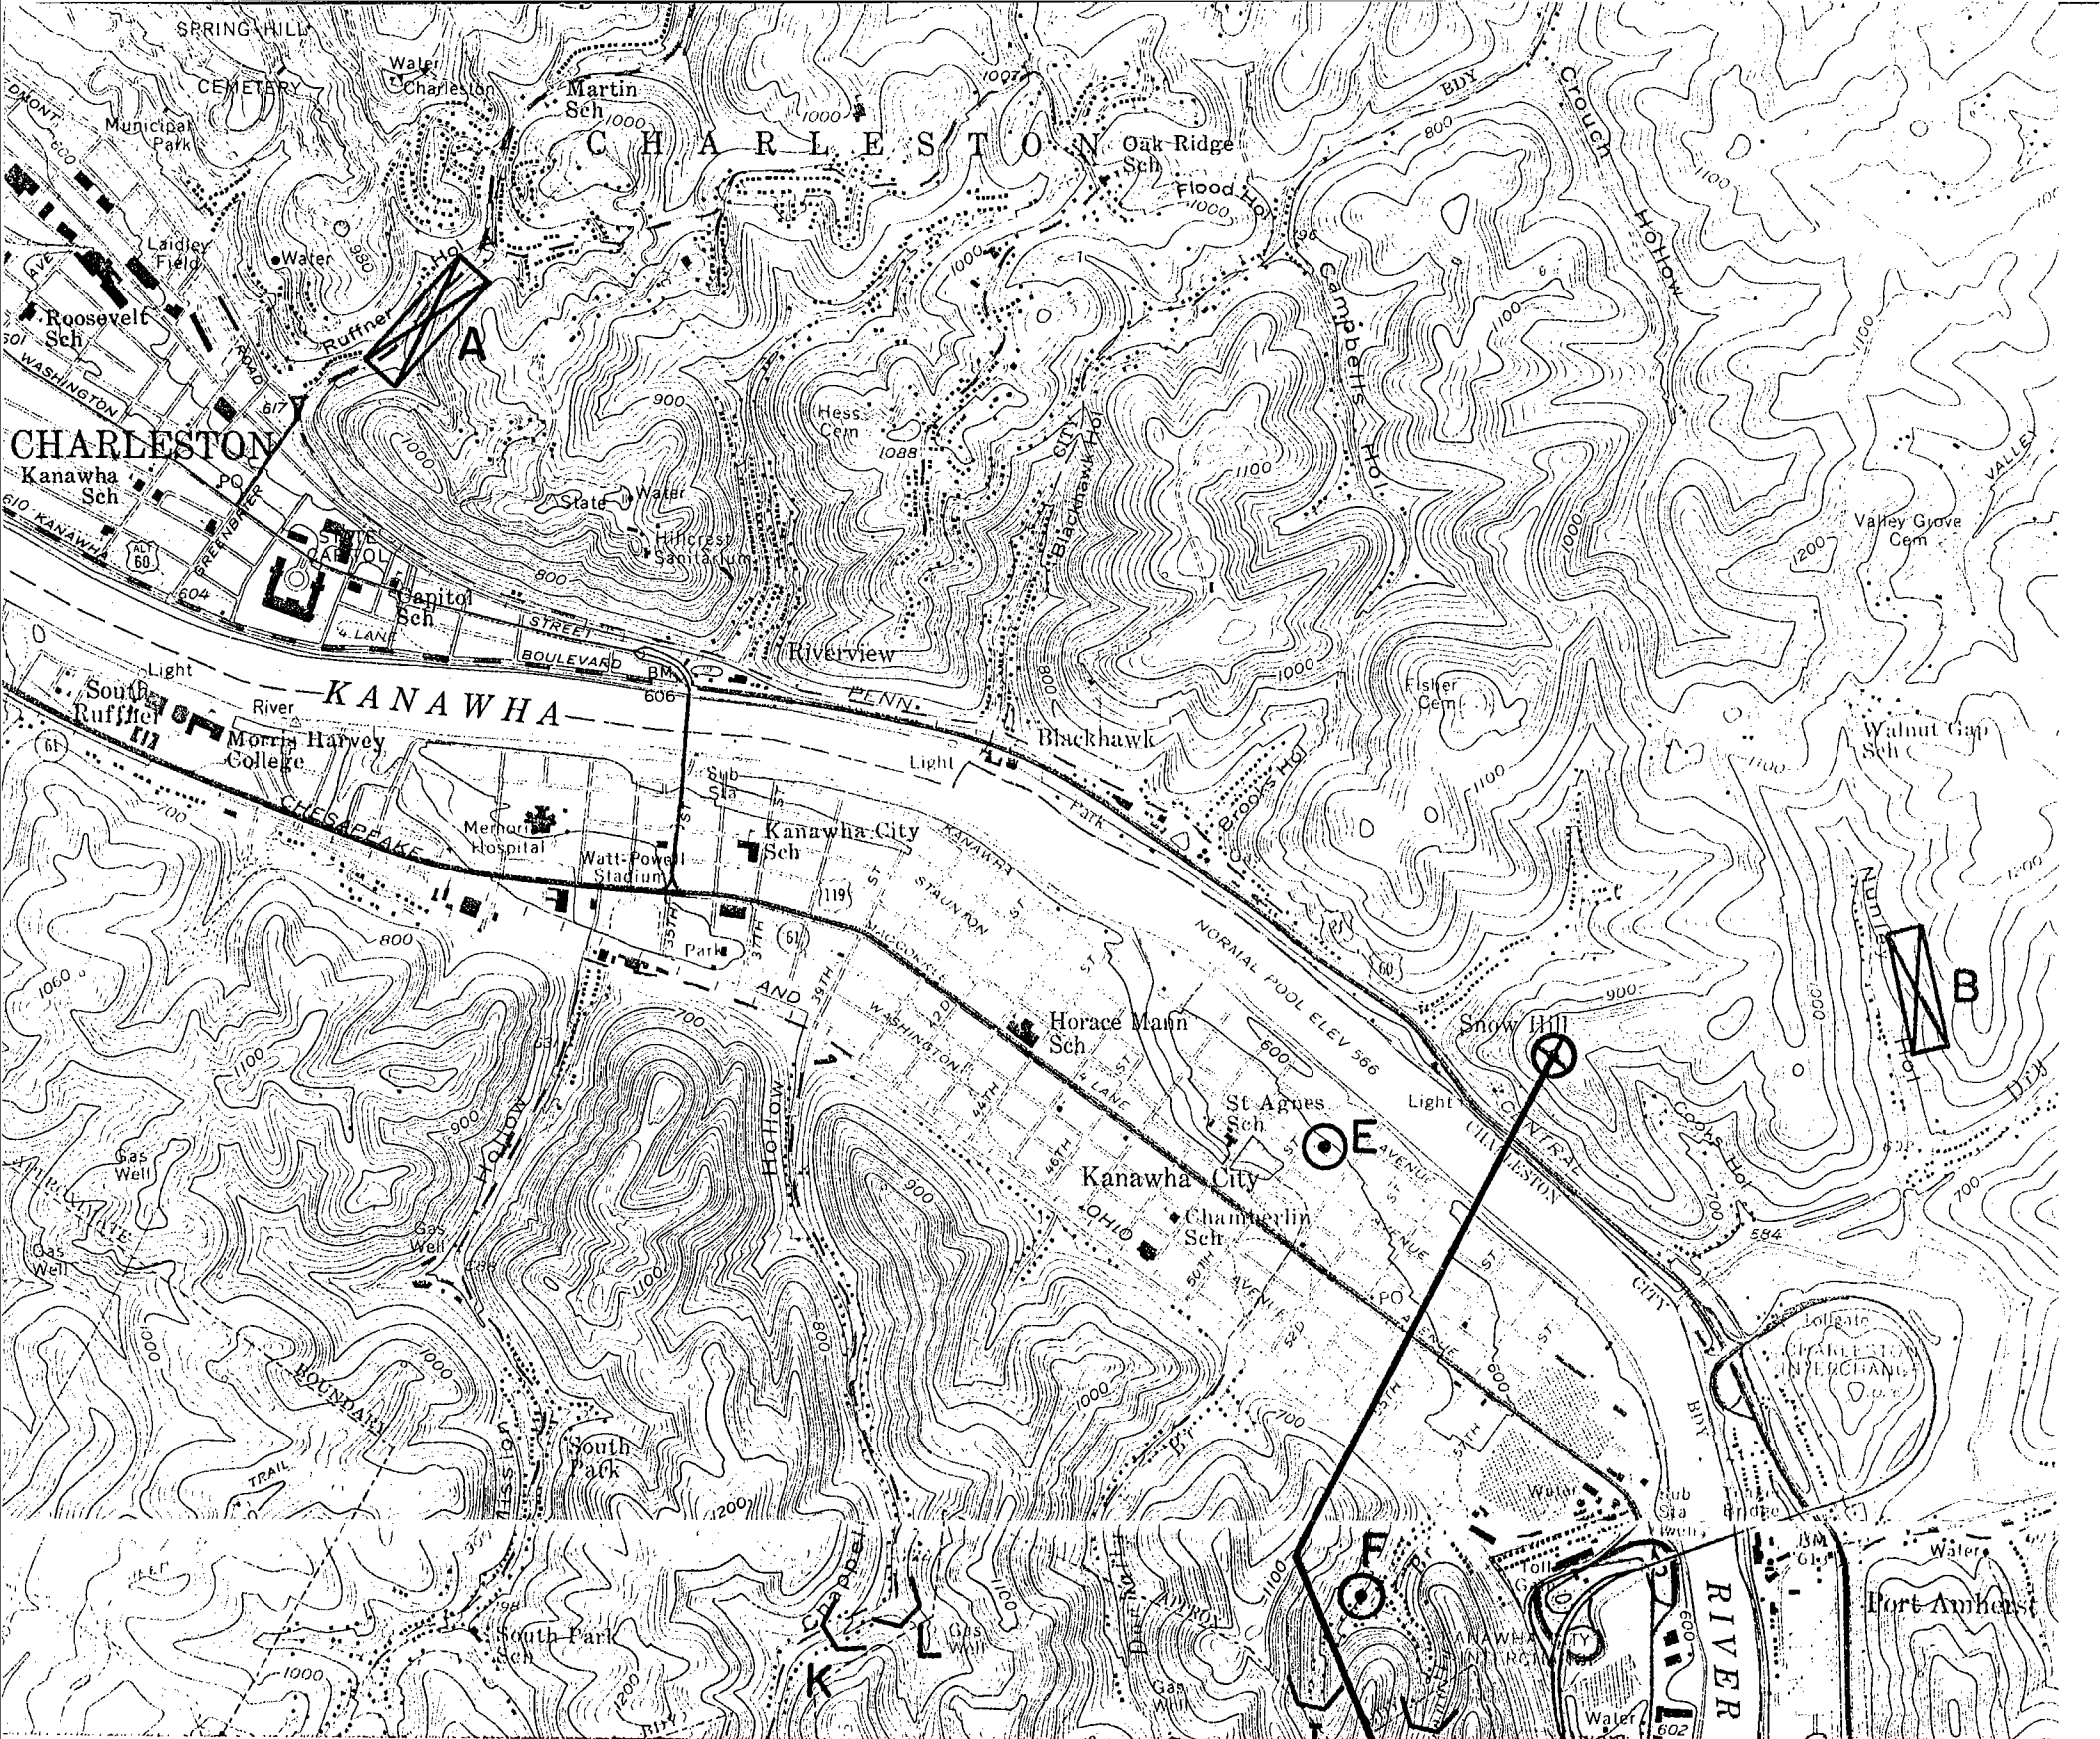
**FIGURE 1**  
**LOCATION OF BASIC DATA FOR KANAWHA**  
**CITY STORM OF JULY 9, 1973**

Between 4 and 6 a.m. on Monday, July 9, 1973, a severe, isolated thunderstorm occurred in the Kanawha City area of Charleston, West Virginia. The following unofficial rainfall measurements were made: greater than 4 inches in Lower Donnally Branch (marked as D on Figure 1); 5 inches at 50th and Kanawha Avenue (marked as E on Figure 1); and 5 to 6 inches in Upper Donnally Branch (marked as F on Figure 1). The intense rainfall caused local flashflooding, the overtopping of several small dams, the failure of one siltation dam, and numerous landslides. These effects are located on Figure 2, where slides F, G, H, I, and K caused minor local damage from soil and debris and slides B, C, D, E, and J caused little or no damage. Slide A totally destroyed three houses on Upper Donnally Road and killed three children. Several sections of Chappell Hollow have artificial dams across the creek with small culverts for normal flow only. These dams backed up the creek and were overtopped during the storm, causing much siltation and flooding, although none failed. A siltation dam on the Right Fork of Rush Creek (marked as N on Figure 2) did fail during the storm, although downstream damage was only minor.

Much of this rock section is concealed in the Kanawha City area. Therefore, the above descriptions are composites of four nearby outcrops: (1) Ruffner Hollow, north of the State Capitol (A on Fig. 1); (2) Nunley Hollow, north of the Charleston interchange of the West Virginia Turnpike (B on Fig. 1); (3) Rush Creek, northwest of Marmet (C on Fig. 1); and (4) Kanawha State Forest, 3 miles southwest of Kanawha City (not shown on Fig. 1).

Peak-flow determinations of the July 9 flood were made by the U. S. Geological Survey (USGS) on Upper Donnally Branch, Lower Donnally Branch, Chappell Hollow, and the Right Fork of Rush Creek (see Figure 1). The results of these determinations are shown in Table 1. Flood peaks range from 96 cfs (cubic feet per second) on the Left Fork of Chappell Hollow to 657 cfs on the Right Fork of Rush Creek. For a better comparison, these discharges were converted to cubic feet per second per square mile (cfs/mi). This is called "unit runoff" and compares the "yield" from each of the basins by adjusting for the size of each drainage area. As indicated by the runoff data, the highest yield occurred in Upper Donnally Branch with each fork contributing about 2,500 cfs/mi. To the south and west, Lower Donnally and the headwaters of the Right Fork of Rush Creek yielded 1,280 and 1,060 cfs/mi, respectively. Farther west, the Left Fork of Chappell Hollow had 640 cfs/mi and the Right Fork had 310 cfs/mi. The runoff pattern indicates that the storm centered over Upper Donnally Branch and Donley Mountain. Although 2,500 cfs/mi is an extremely high unit runoff, it is possible to obtain this amount of flow under certain conditions, particularly from such small drainage areas.
